# **Reserve Study Report**

## **Level I Full With-Site-Visit Study**

### **Mauna Lani Resort Association**

<b>Report</b>	<b># 1042-0</b>
<b>Prepared</b>	<b>October 12, 2018</b>
<b>Fiscal Year</b>	<b>January 1, 2019 through December 31, 2019</b>
<b>Report Expires</b>	<b>December 31, 2019</b>

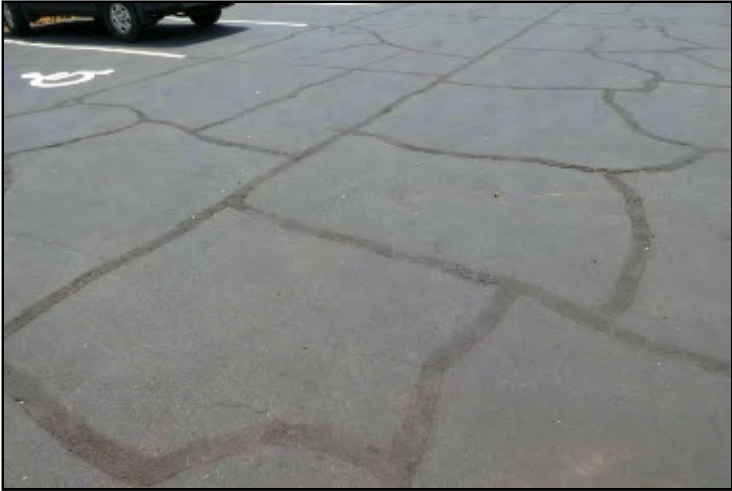
Component:	101 - Admin Parking Asphalt - Replace	Quantity:	Approx. 13,200 GSF
Location:	Administration Building parking lot and driveway from Ho Ohana Road		
Cost Source:	Akamai Reserves Cost Database	Useful Life:	30 Remaining Useful Life:17
Best Case:	\$66,000 Estimate for cold planing and 1.5" resurface		
Worst Case:	\$105,600 Higher estimate extensive repairs and topcoat

**Evaluation:** Surface has deep crack filling and patches for a fair condition. Overlaid in 2005, but cracks may have transferred from unrepaired subsurface.

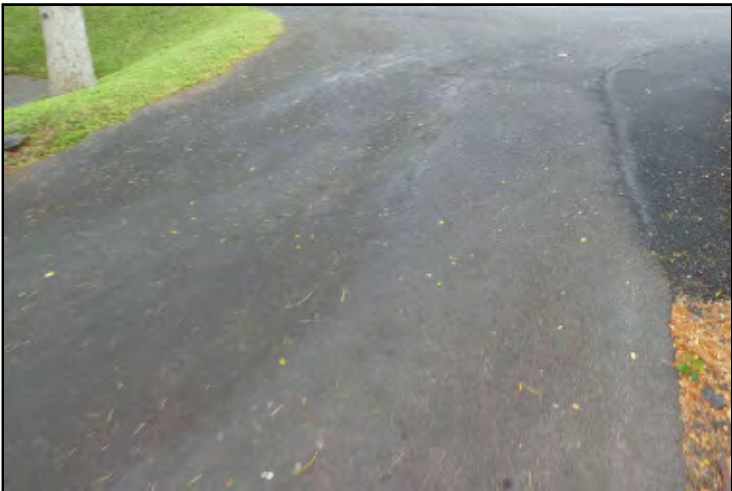
Component:	101 - Historic Park Parking Asphalt - Replace	Quantity:	Approx. 11,500 GSF
Location:	Historic Park and restrooms		
Cost Source:	Akamai Reserves Cost Database	Useful Life:	30 Remaining Useful Life:13
Best Case:	\$57,500 Estimate for cold planing and 1.5" resurface		
Worst Case:	\$92,000 Higher estimate extensive repairs and topcoat

**Evaluation:** Surface has deep crack filling, uplifts and patches.

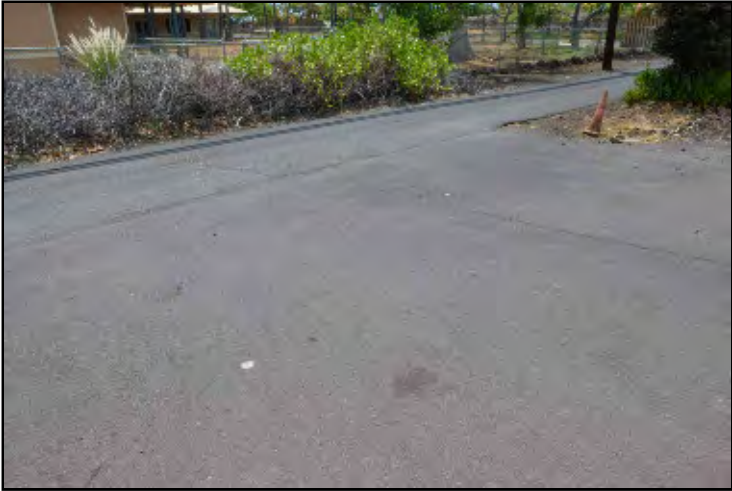
Component:	101 - Maintenance Yard Asphalt - Replace	Quantity:	Approx. 30,700 GSF
Location:	Service road and Yard		
Cost Source:	Akamai Reserves Cost Database	Useful Life:	30
Best Case:	\$153,500	Remaining Useful Life:	7
Worst Case:	\$245,600		
	Estimate for cold planing and 1.5" resurface		
	Higher estimate extensive repairs and topcoat

**Evaluation:** Surface has deep cracks and patches for an aged fair to poor condition.

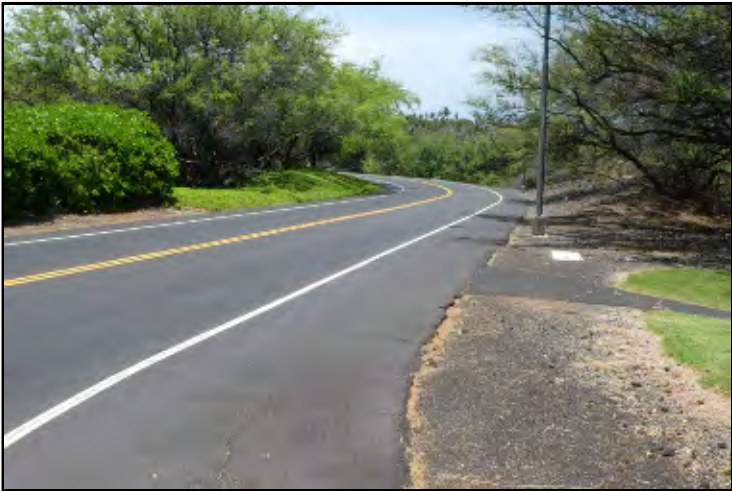
Component:	101 - Mauna Lani Drive Asphalt Phase 1 - Replace	Quantity:	Approx. 91,300 GSF
Location:	Mauna Lani Drive Traffic Circle to Mauna Lani Hotel/ML Terrace intersection		
Cost Source:	Akamai Reserves Cost Database	Useful Life:	30
Best Case:	\$365,200	Remaining Useful Life:	10
Worst Case:	\$547,800		
	Estimate for cold planing and 1.5" resurface		
	Higher estimate extensive repairs and topcoat

**Evaluation:** Surface is in a fair and dry condition.

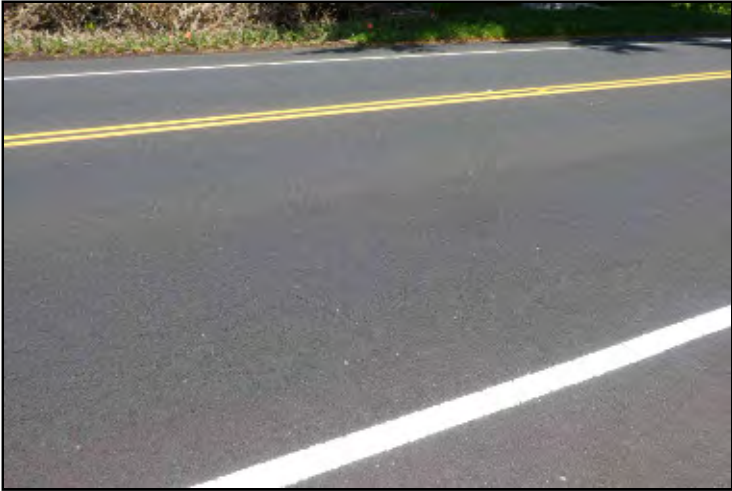
Component:	101 - Mauna Lani Drive Asphalt Phase 2 - Replace	Quantity:	Approx. 466,000 GSF
Location:	Mauna Lani Drive entry to traffic circle includes Circle; North Kaniku Drive		
Cost Source:	Akamai Reserves Cost Database	Useful Life:	30 Remaining Useful Life:25
Best Case:	\$1,864,000 Estimate for cold planing and 1.5" resurface		
Worst Case:	\$2,796,000 Higher estimate extensive repairs and topcoat

Evaluation: Surface is level and in fair condition.

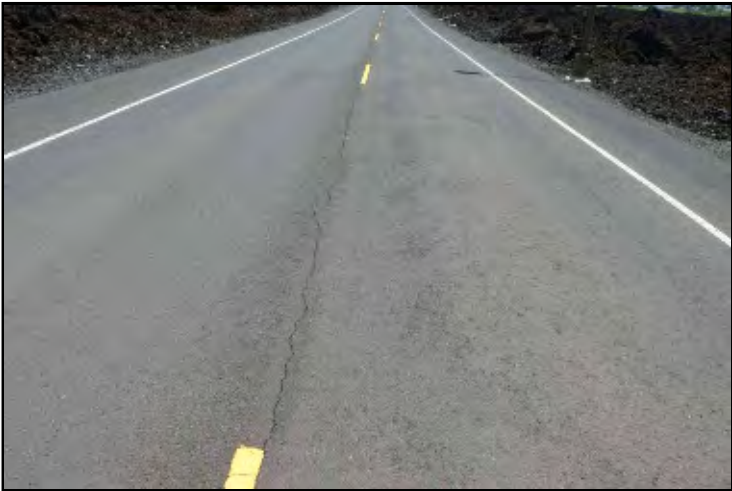
Component:	101 - Na Ala Hele Asphalt - Replace	Quantity:	Approx. 86,600 GSF
Location:	Na Ala Hele Road		
Cost Source:	Akamai Reserves Cost Database	Useful Life:	30 Remaining Useful Life:13
Best Case:	\$346,400 Estimate for cold planing and 1.5" resurface		
Worst Case:	\$519,600 Higher estimate extensive repairs and topcoat

Evaluation: Surface is level and in dry fair condition. Cold joints starting to separate.

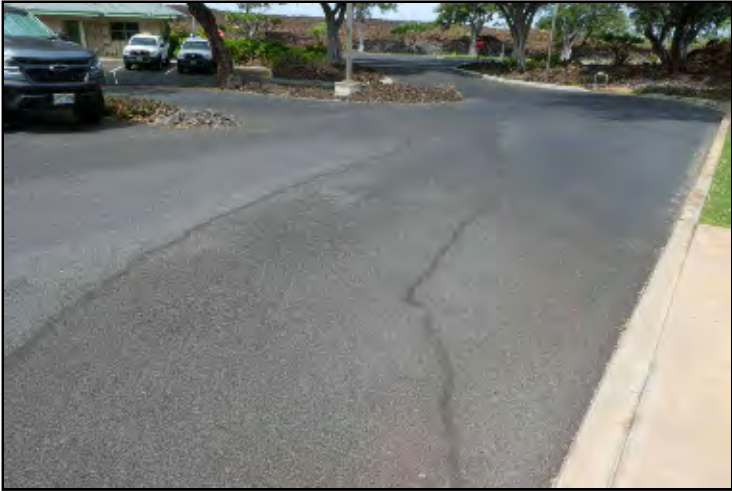
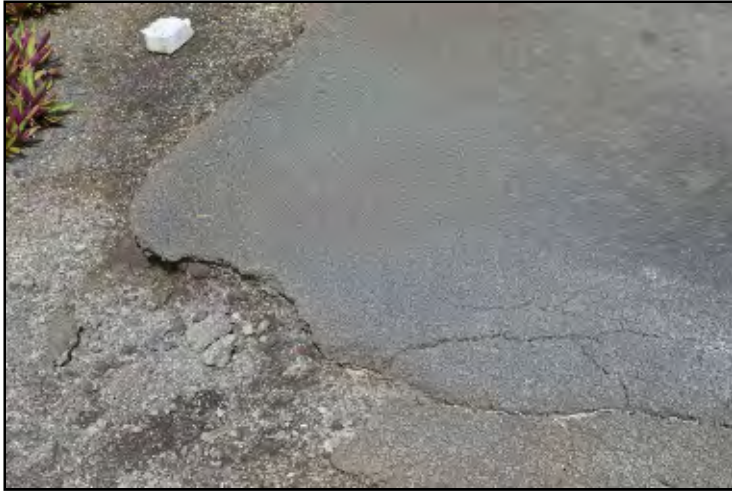
101 - Security Parking Asphalt - Replace

**Evaluation:** Surface is in dry and cracked fair condition. Staining and damage due to water runoff.

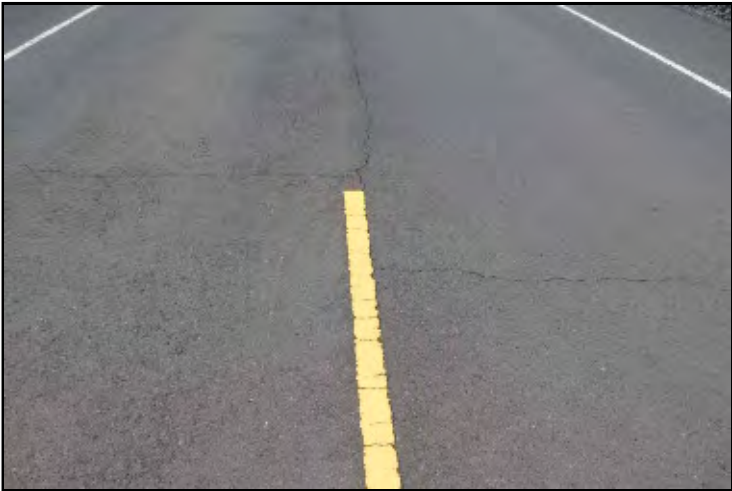
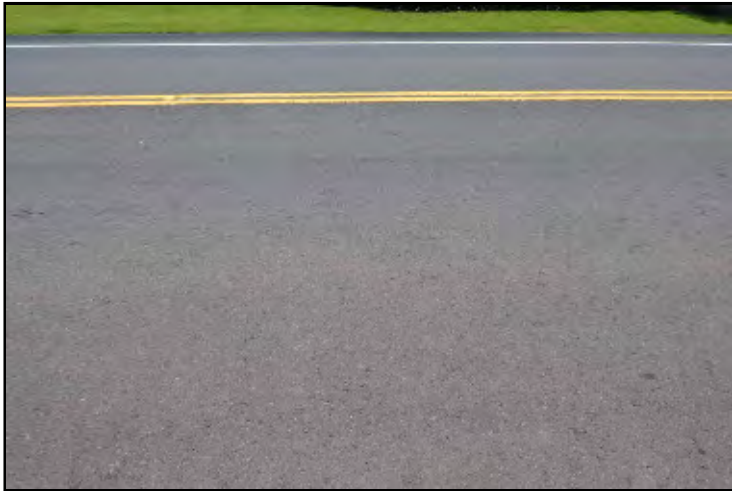
**Evaluation:** Surface is level and in fair condition.

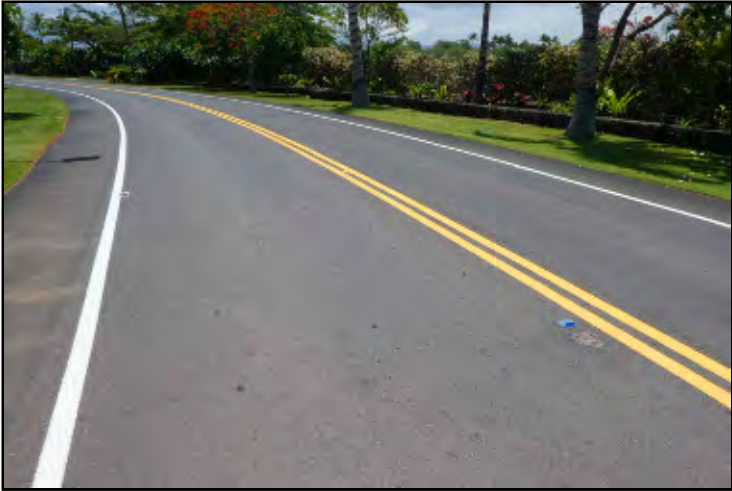
Component:	101 - South Pauoa Asphalt - Replace	Quantity:	Approx. 40,200 GSF
Location:	South Pauoa Road Mauna Lani Drive intersection to Islands at Mauna Lani		
Cost Source:	Akamai Reserves Cost Database	Useful Life:	30 Remaining Useful Life:19
Best Case:	\$160,800 Estimate for cold planing and 1.5" resurface		
Worst Case:	\$241,200 Higher estimate extensive repairs and topcoat

Evaluation: Surface is level and in fair condition.

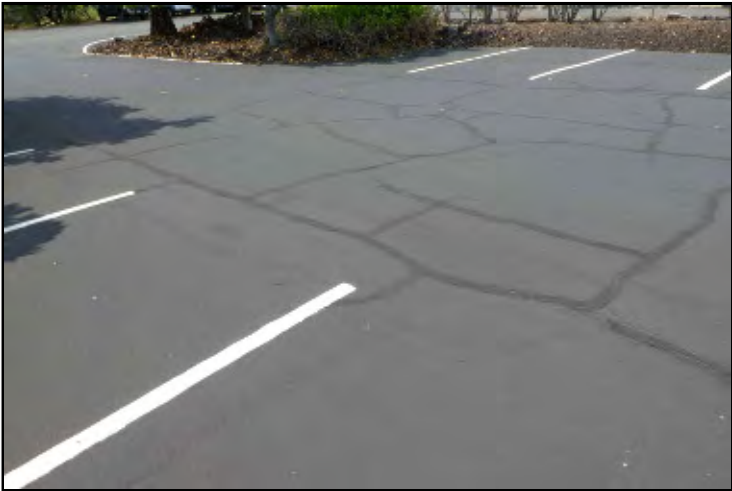
Component:	111 - Admin Parking Asphalt - Seal/Repair	Quantity:	Approx. 13,200 GSF
Location:	Administration Building parking lot		
Cost Source:	Client Cost History	Useful Life:	6 Remaining Useful Life:4
Best Case:	\$8,580 Estimate for seal coat and repair		
Worst Case:	\$9,240 Higher estimate for additional repairs

Evaluation: Surface has deep crack filling and patches for a fair drying condition.

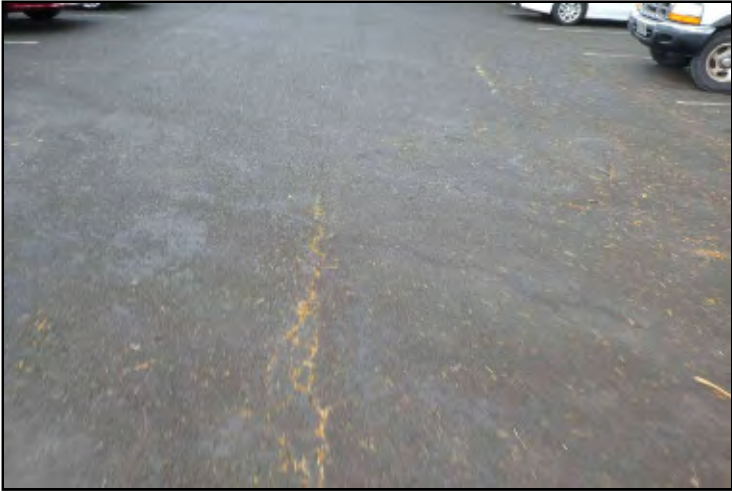
**Evaluation:** Surface is in fair condition with cracking and uplifts.

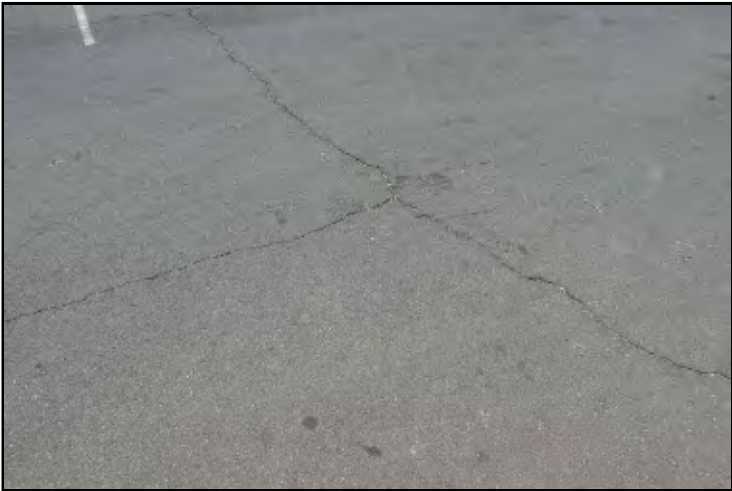
**Evaluation:** Surface has deep cracks, dry, raveling and patches for an aged poor condition. This is a low priority section of asphalt.

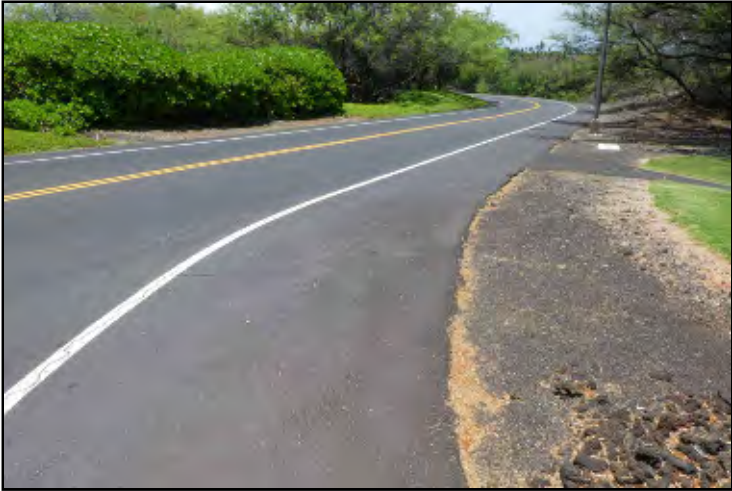
**Evaluation:** Surface is in general fair drying condition.

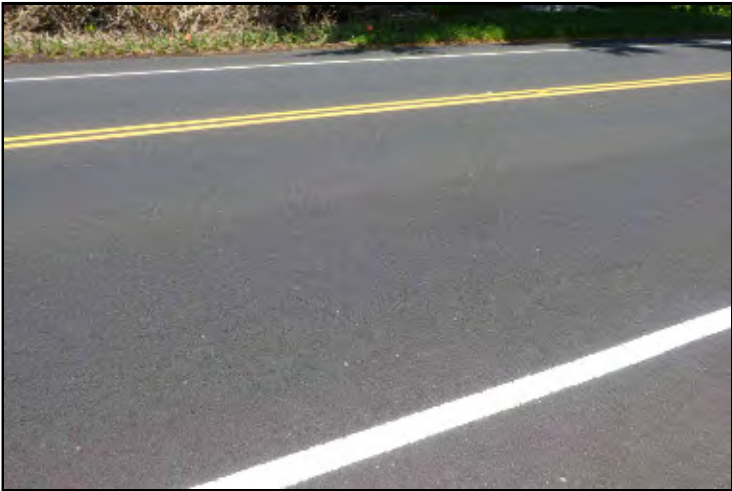
**Evaluation:** Surface is level and in fair condition.

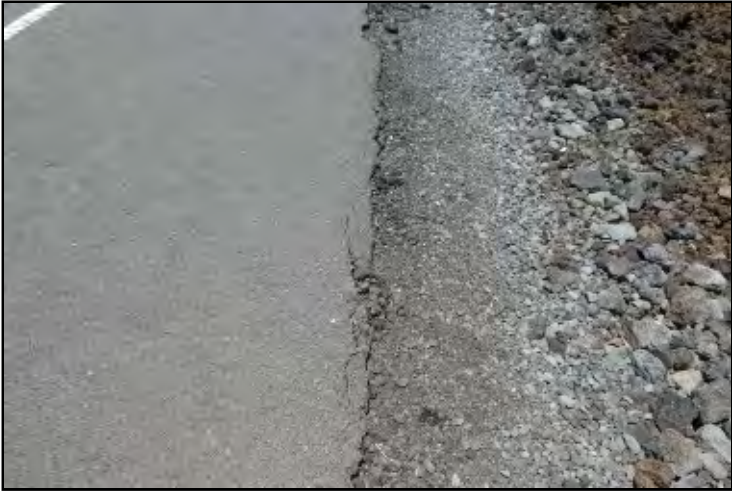
**Evaluation:** Surface is level and in drying fair condition.

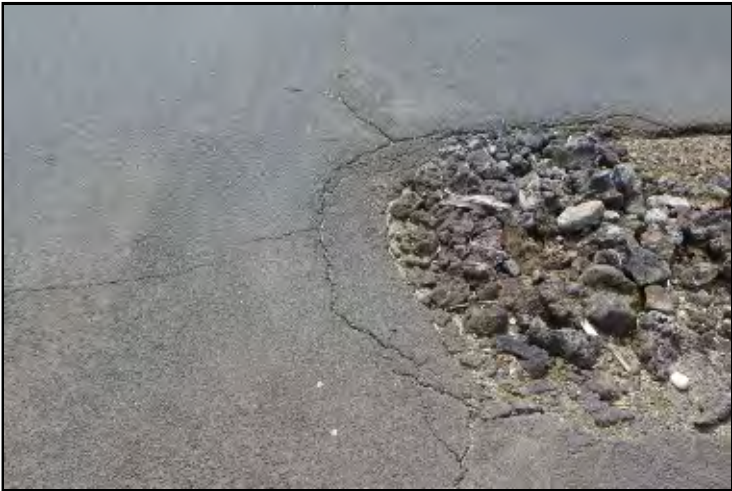
**Evaluation:** Surface is in dry, cracked fair condition.

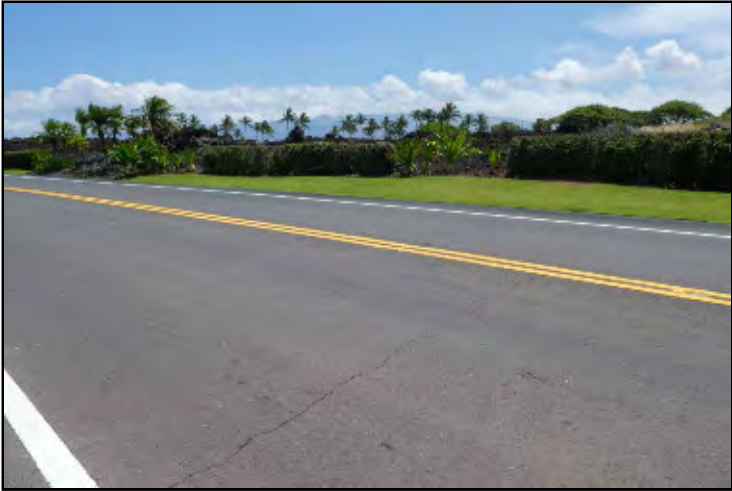
**Evaluation:** Surface is in level, dry, cracking and aged fair condition.

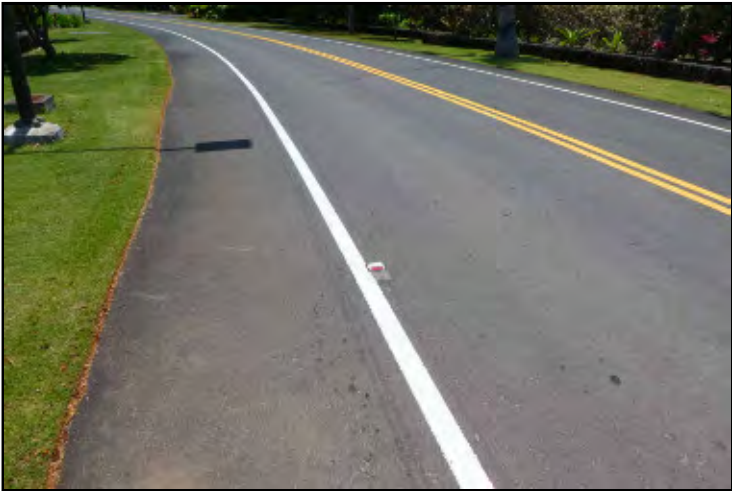
**Evaluation:** Surface is level and in fair condition.

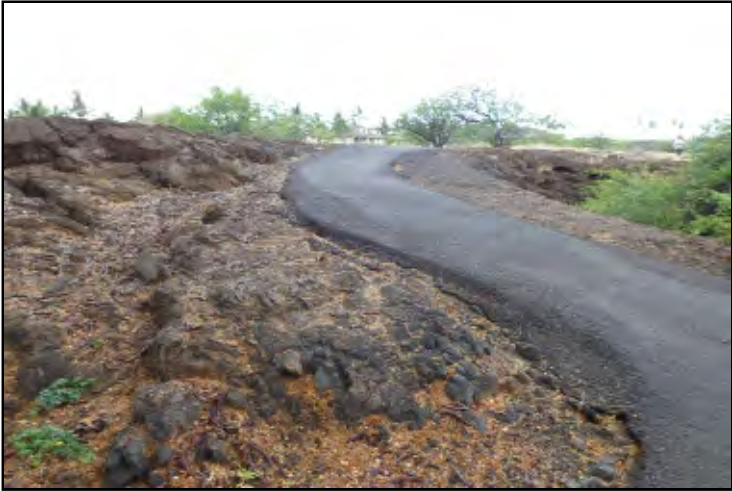
125 - Asphalt Path - Replace

Evaluation: The 5 foot wide surface has is in fair condition with no reported major issues.

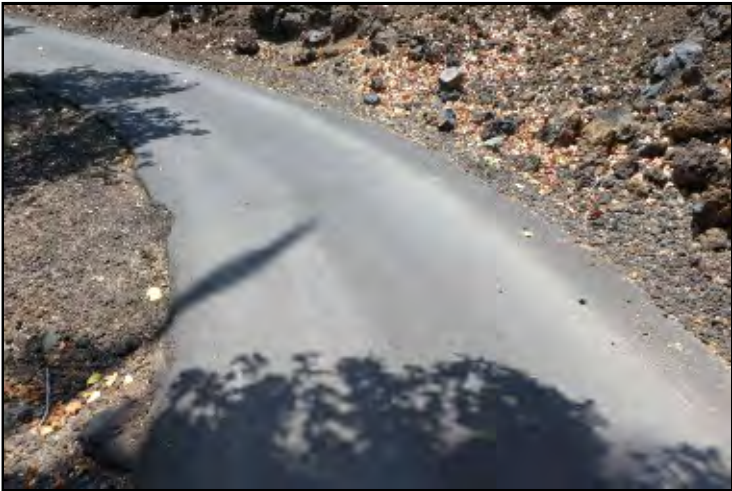
Evaluation: The 5 foot wide surface is in fair condition and appearance with minor cracking.

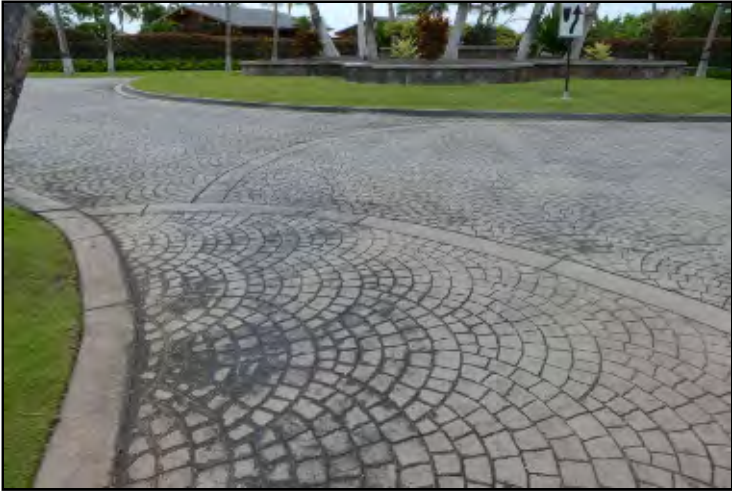
**Evaluation:** Level textured surface is in fair condition. Cracks in a few places. No expectation for full replacement, but expect small repairs in the future.

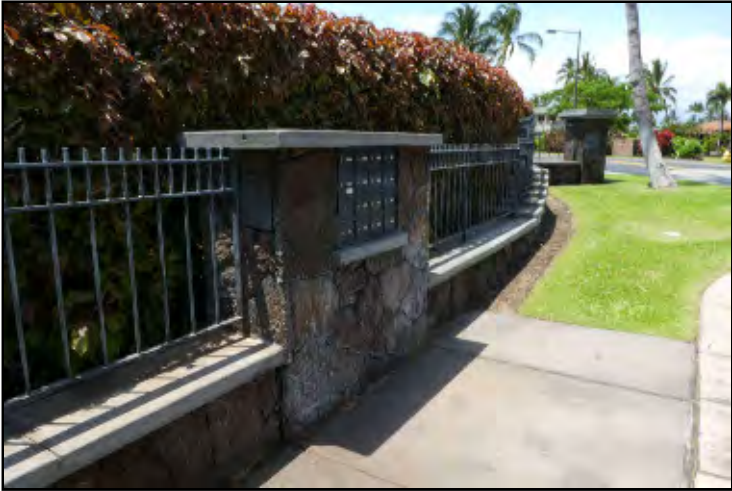
Evaluation: The wall is in fair condition and appearance.

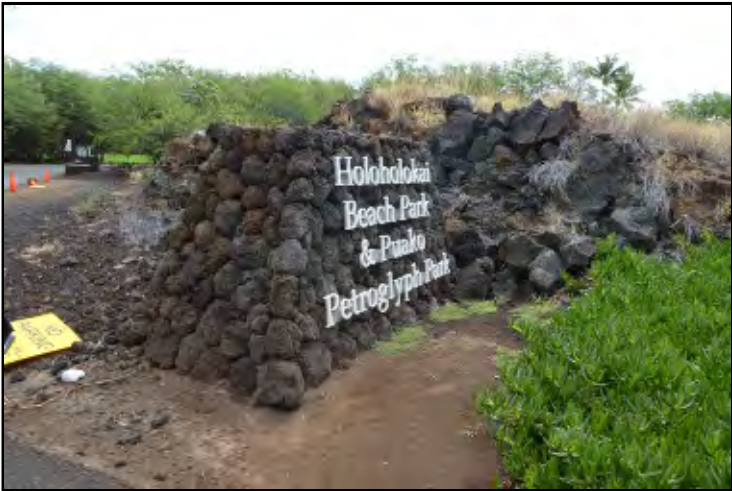
Evaluation: Walls and monument signs are in fair condition and appearance. Cost is to complete small repairs.

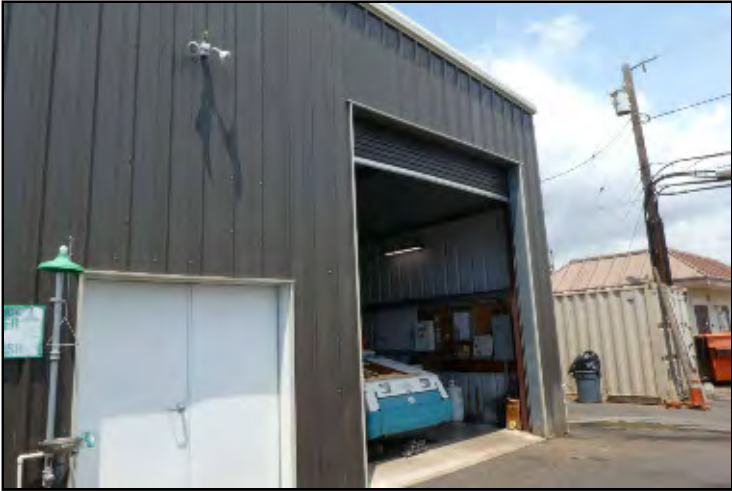
**Evaluation:** The 18 x 12 ft doors and operators are in fair functional condition and are well maintained.

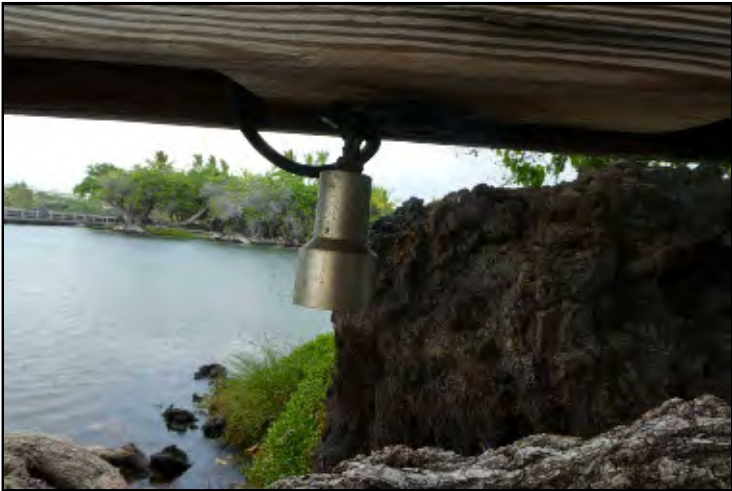
**Evaluation:** Lights are in fair condition with no reported issues.

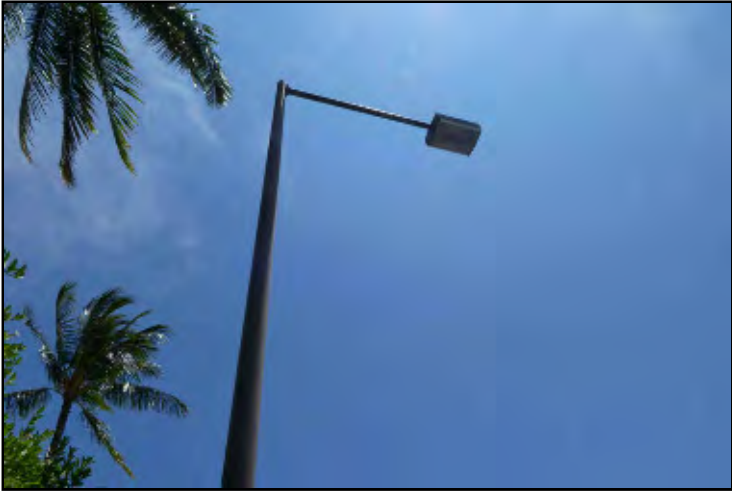
Evaluation:      The 25ft pole lights are in varied condition. Cost is for replacement of 5 light poles due to damage or corrosion of bases, anchor bolts and electrical junction box.

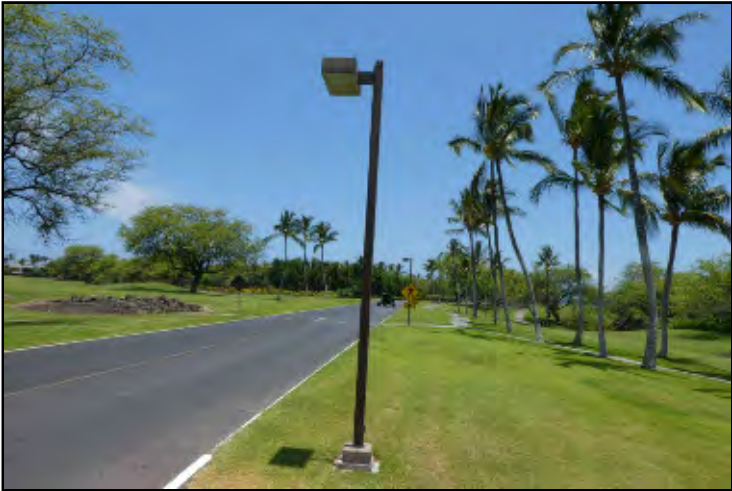
Evaluation:      The 25ft pole lights are in varied condition. Cost is to replace all pole lights with LED pole lights.

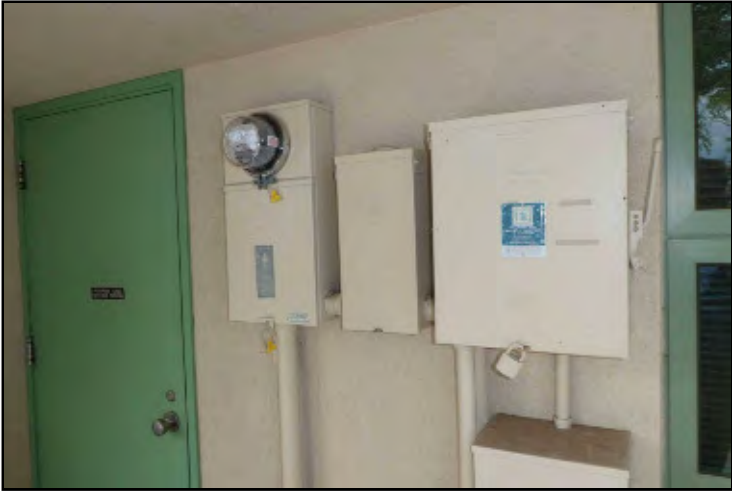
Evaluation: Inspection by professional electrician to tighten contacts, replace faulty breakers, corroded components and upgrade to current code will save energy, protect equipment, and prevent fires and other damage.

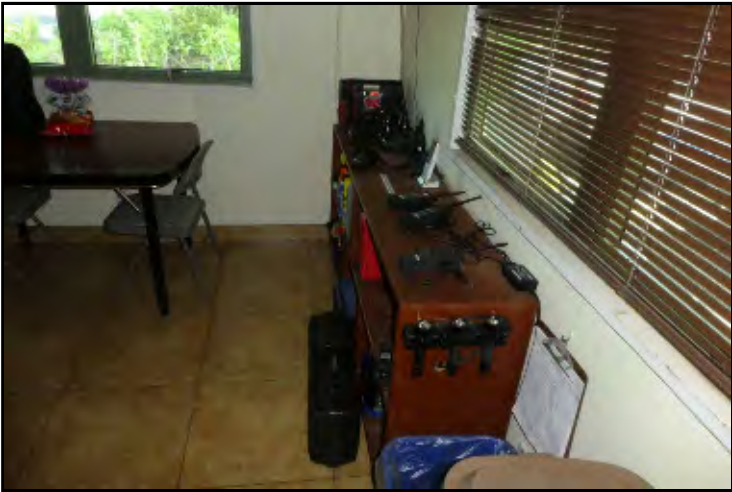
Evaluation: System was upgraded and replaced in 2016. Reported to be in working condition with no issues.

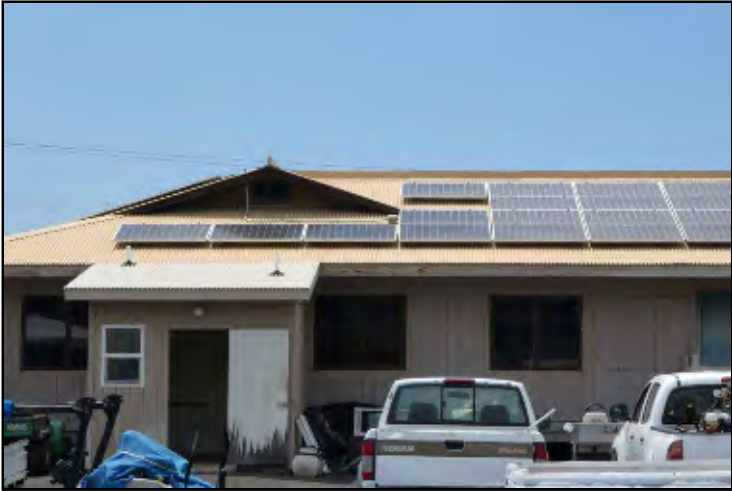
Evaluation: Solar systems were installed in 2015. Reported to be in good functional condition.

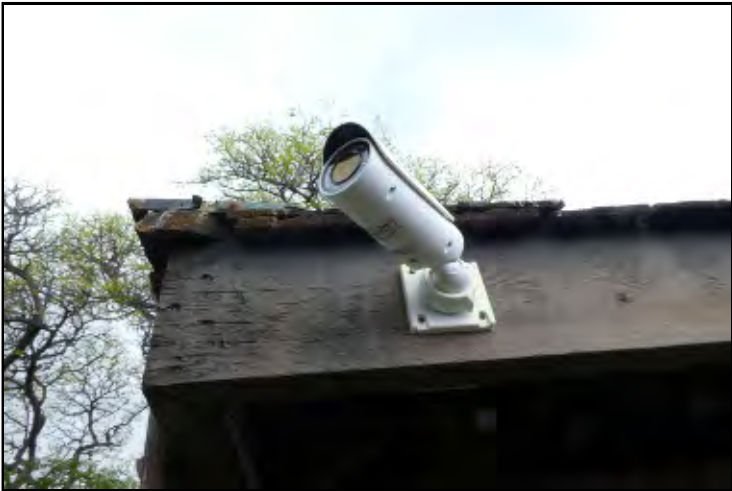
Evaluation: There are two servers and various cameras including the license plate reader. Individual cameras are replaced as needed under the Operating Budget.

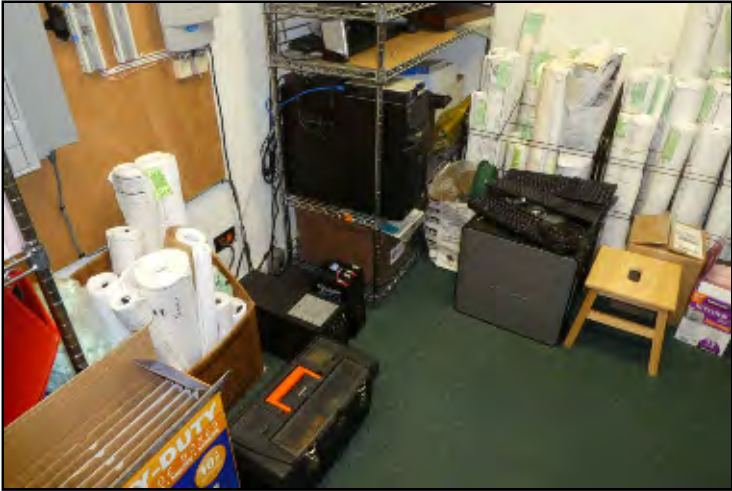
Evaluation: Server and Uninterruptible Power Supply are reported in fair functional condition.

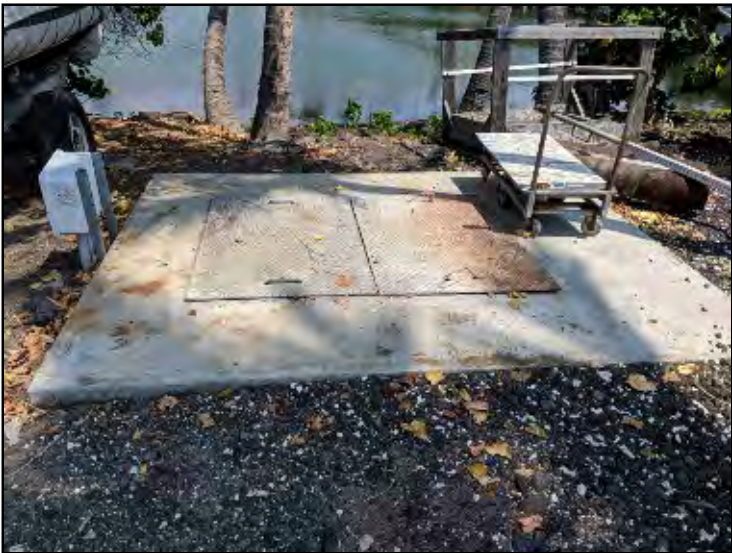
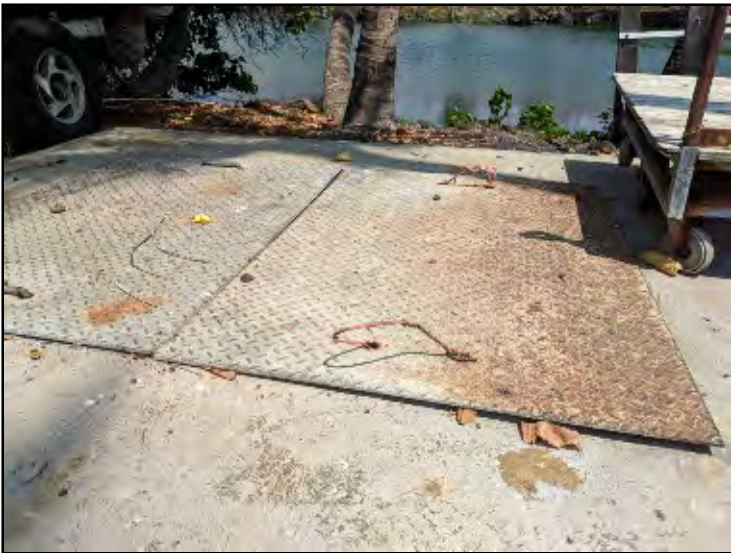
Evaluation: Lift station access lid is in need of repairs and replacement.

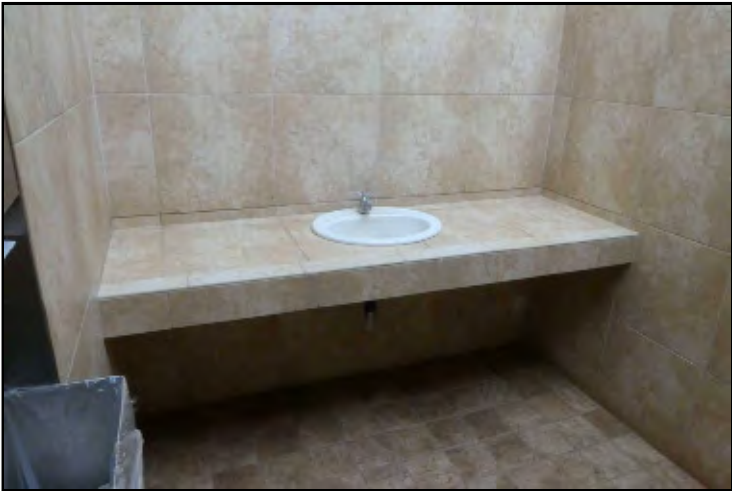
**Evaluation:** The wall mounted fixtures, accessories and minimal paint are in fair condition.

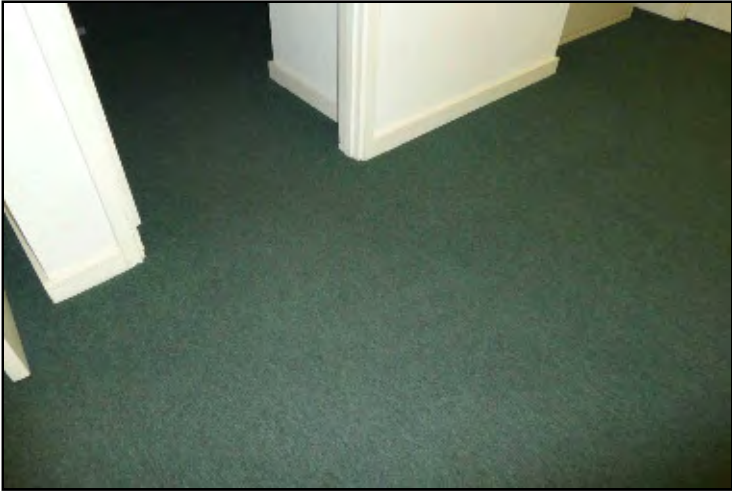
Evaluation: Carpet is in fair condition and appearance.

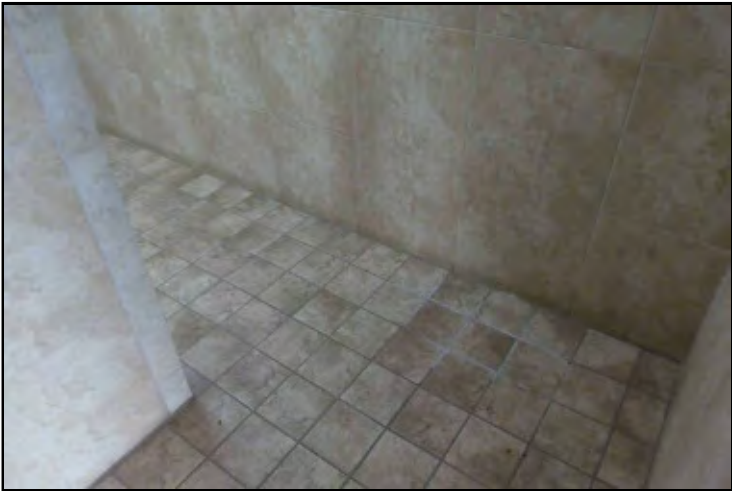
Evaluation: Ceramic tile is in fair condition with minor staining and grime. Eventual full replacement to contemporary decor anticipated.

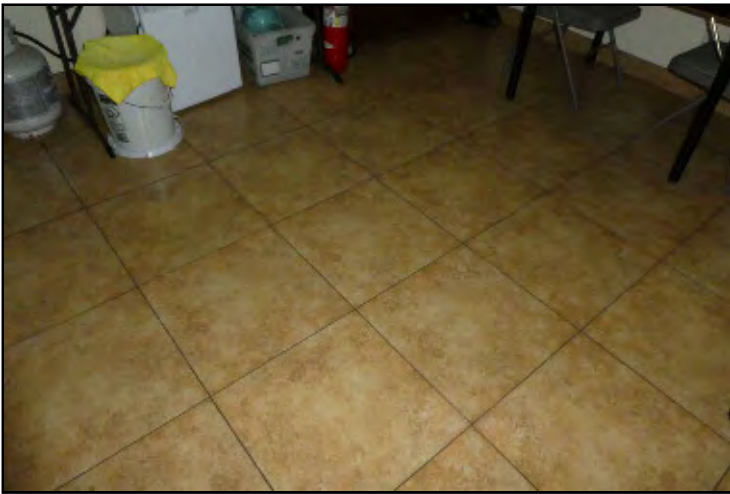
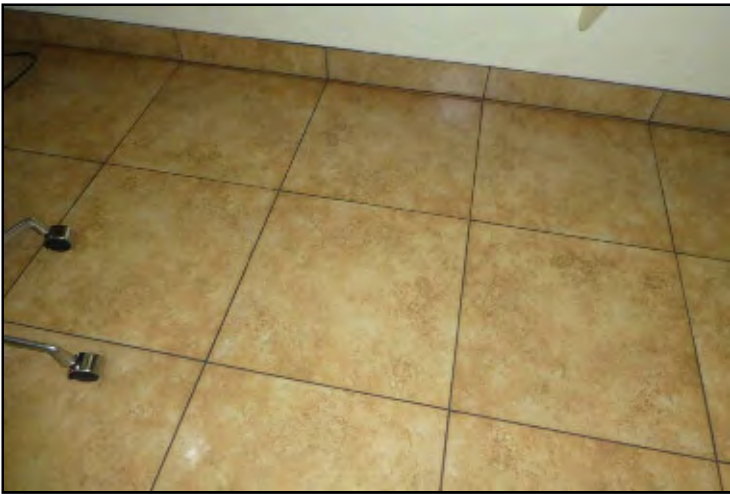
**Evaluation:** Tile installed in 2015 is in fair condition and has a good appearance.

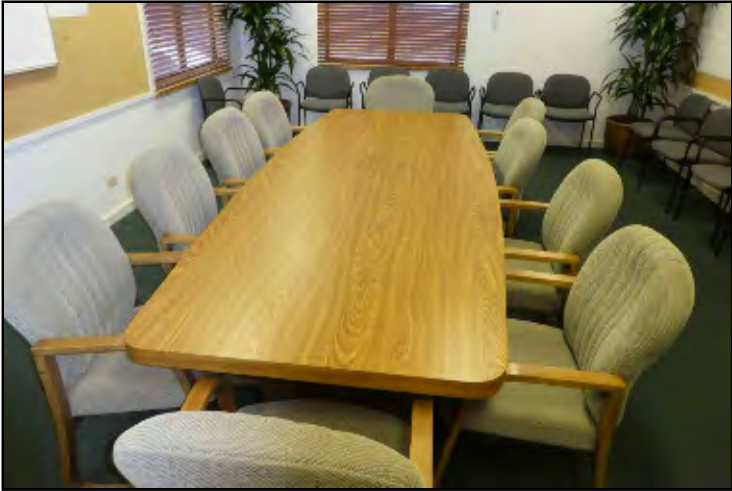
**Evaluation:** Wood frame cushioned chairs and conference table are in fair condition.

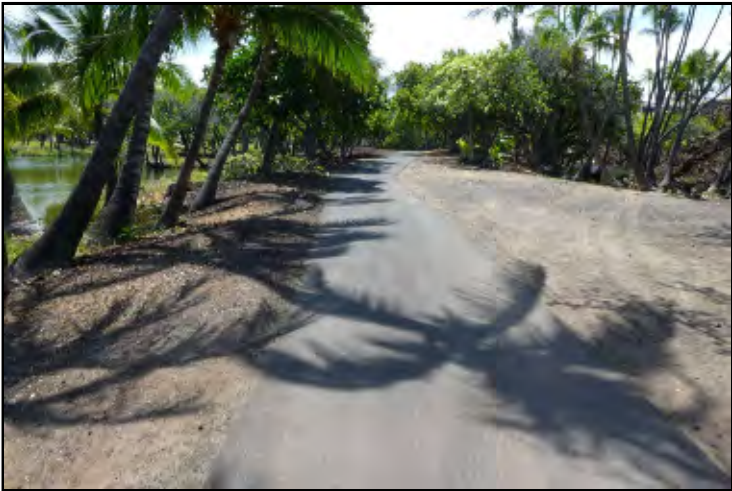
**Evaluation:** Extensive irrigation system maintained by outside contractor under Operating Budget. Wireless control system hardware and software are Reserve components.

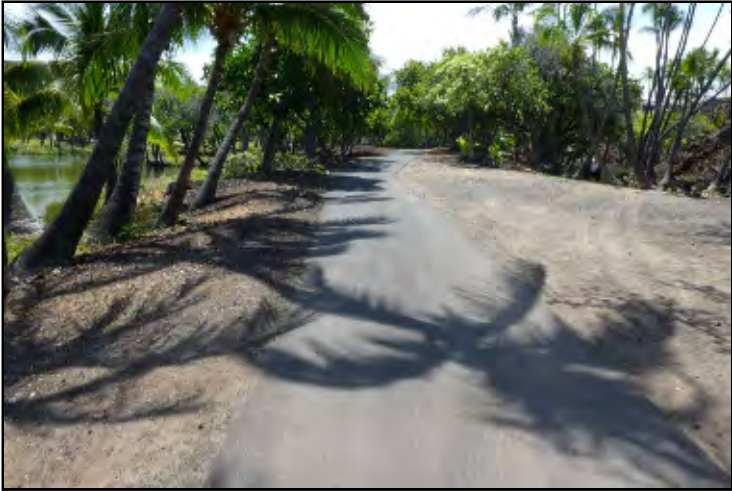
Evaluation: Extraordinary repairs, replacements, and retrofits of irrigation equipment have occurred on this cycle.

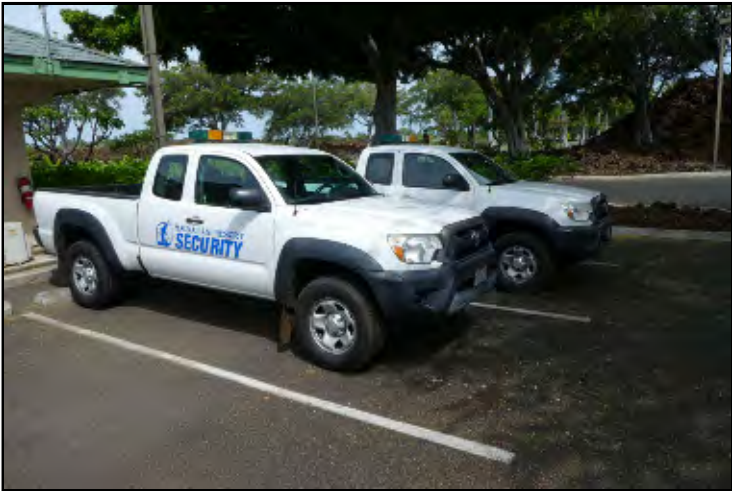
Evaluation: One Toyota Tacoma X Cab was replaced in 2017 and is in good condition for security guard operations. Two more are due to be replaced in 2019. Used trucks are turned over to the maintenance and landscape operations.

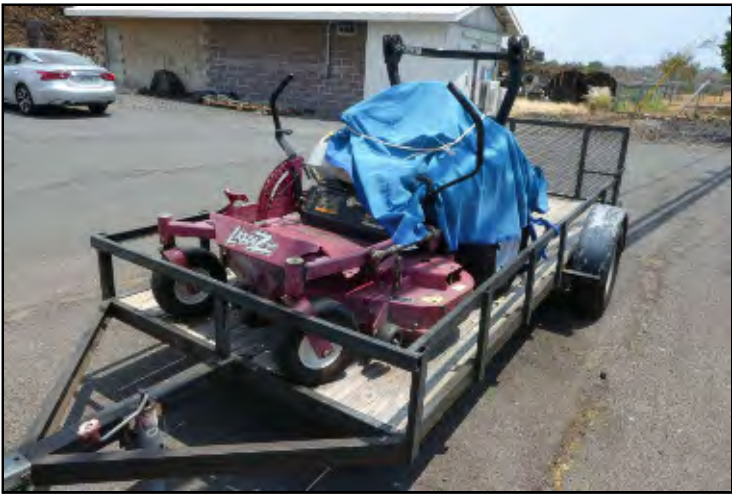
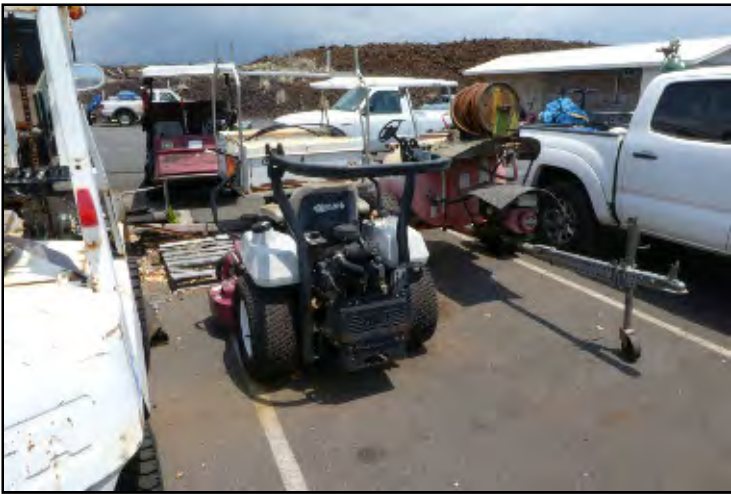
**Evaluation:** Riding mowers are in fair functioning condition.

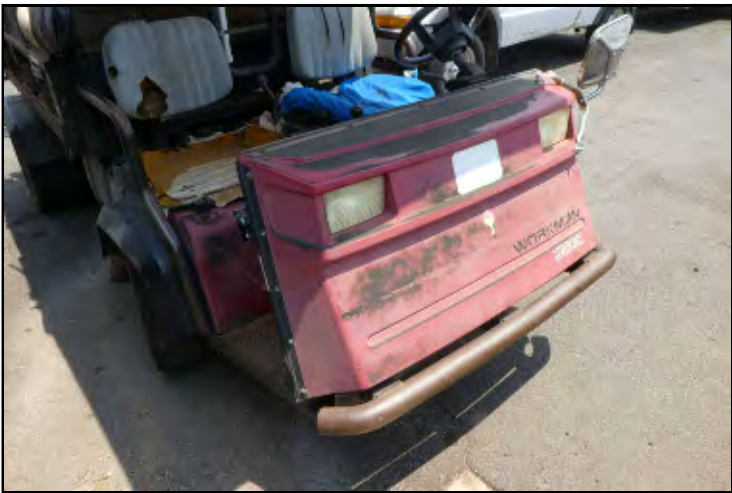
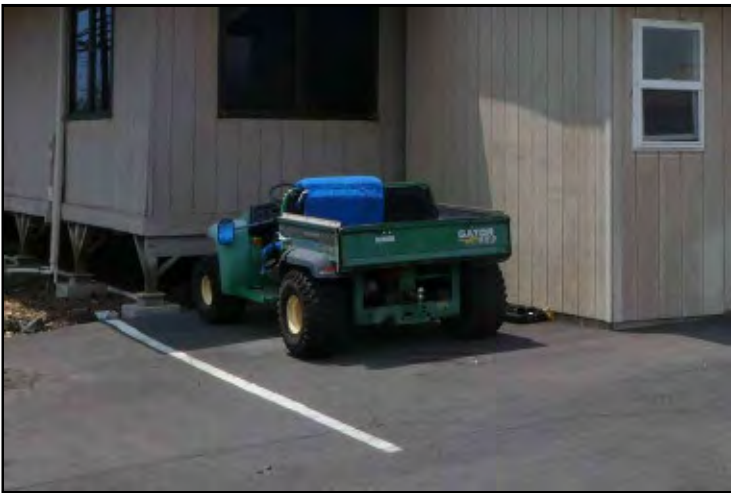
**Evaluation:** The carts are a 2002 model 3200 Toro Workman and a 2007 Gator. Both carts are in reported fair condition. Carts show normal wear and age.

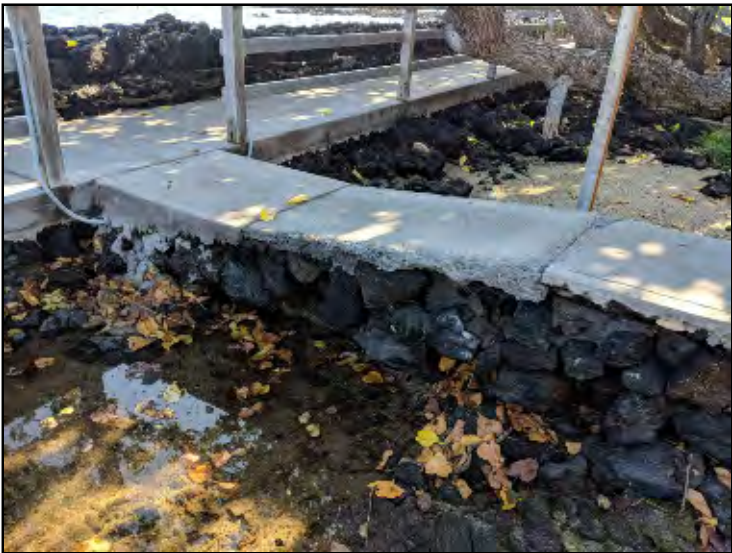
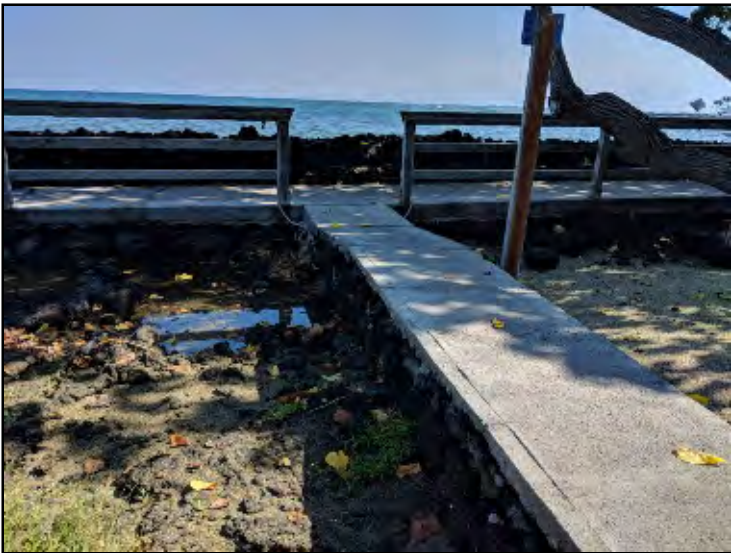
Evaluation: Rock and concrete sea wall is in fair condition. Storm damage is unpredictable and immediate repairs are handled under the Operating Budget as needed.

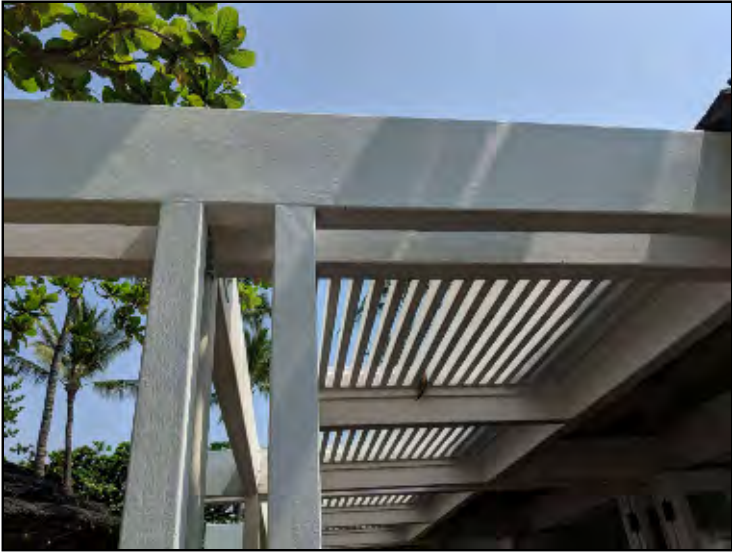
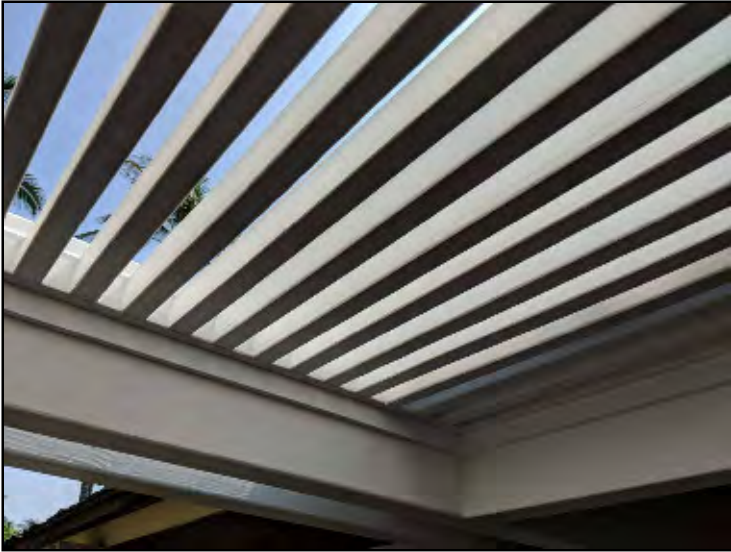
**Evaluation:** Wood trellis roof is in good condition and appearance. New Trellis was installed in 2018.

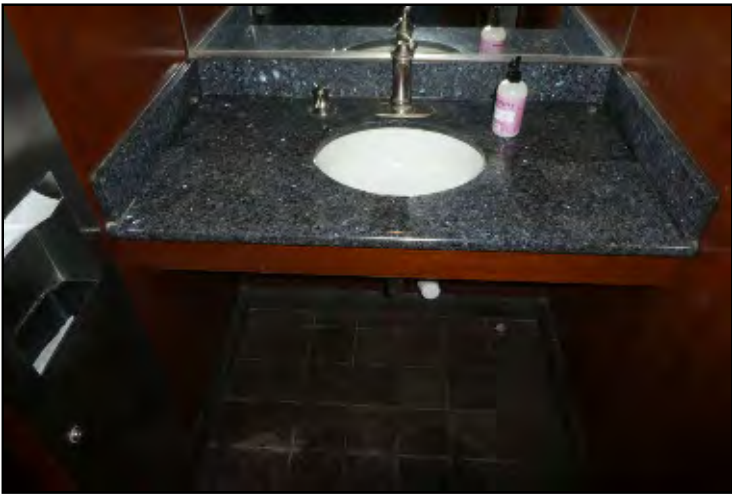
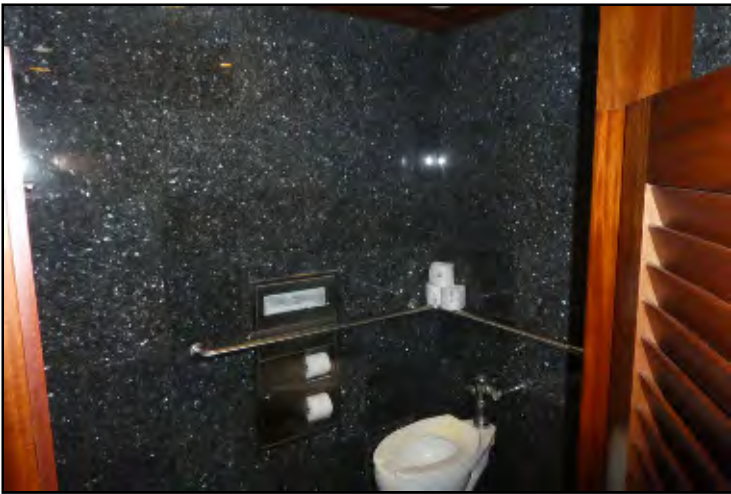
Component:	710 - Restrooms - Remodel	Quantity:	(2) 100 GSF Rm
Location:	South side of building with exterior entries		
Cost Source:	Akamai Reserves Cost Database	Useful Life:	15 Remaining Useful Life:6
Best Case:	\$8,000      \$4,000/Room; Estimate to refurbish		
Worst Case:	\$10,000      \$5,000/Room; Higher estimate to refurbish

**Evaluation:** The attractive rooms have fair condition fixtures, counters, tile and mahogany paneling installed in 2009. The slate tile floors and granite tile walls will require small repairs in the future under the Operating budget.
