# **Reserve Study Report**

## **Level I Full With-Site-Visit Study**

### **Mauna Lani Resort Association**

<b>Report</b>	<b># 1042-0</b>
<b>Prepared</b>	<b>October 12, 2018</b>
<b>Fiscal Year</b>	<b>January 1, 2019 through December 31, 2019</b>
<b>Report Expires</b>	<b>December 31, 2019</b>

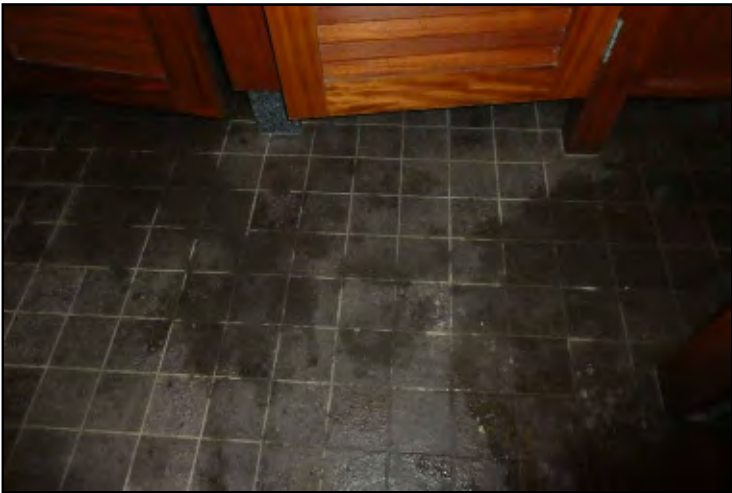
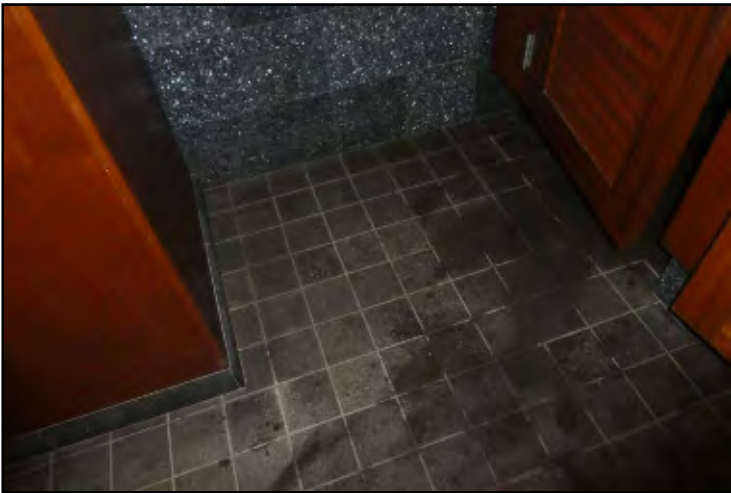
Component:	714 - Tile Floor - Replace	Quantity:	Approx. 200 GSF
Location:	South side of building with exterior entries		
Cost Source:	Akamai Reserves Cost Database	Useful Life:	20 Remaining Useful Life:11
Best Case:	\$5,000      \$25/GSF; Estimate to replace tile		
Worst Case:	\$7,000      \$35/GSF; Higher estimate

**Evaluation:** The slate tile floor installed in 2009 is in fair condition and appearance. Minor repairs of tile to be completed under the Operating Budget.

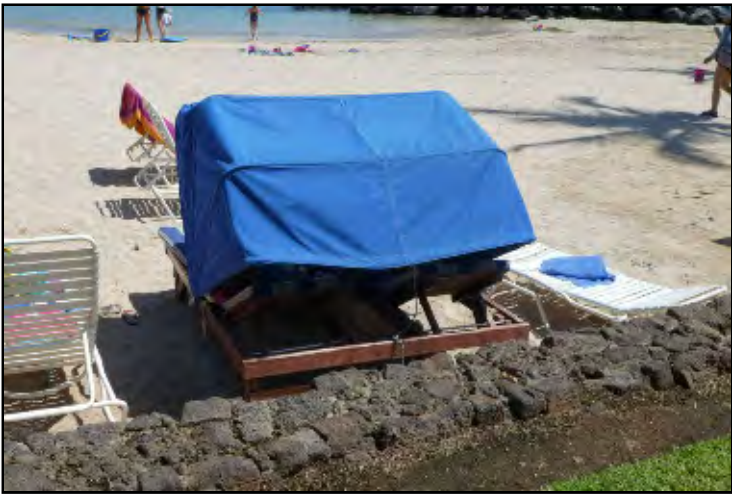
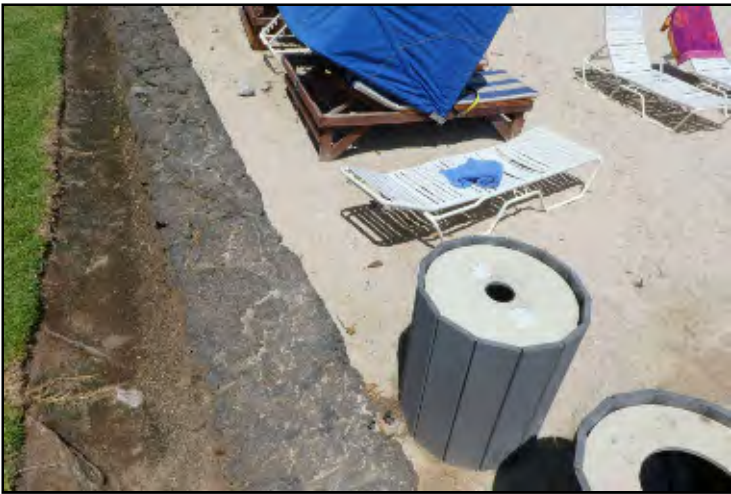
Component:	726 - Cabana Soft Goods - Replace	Quantity:	(16) Cabanas
Location:	Beach at Makaiwa Bay		
Cost Source:	Client Cost History	Useful Life:	4
Best Case:	\$10,000	Remaining Useful Life:	1
Worst Case:	\$11,000		
	Estimate to Replace Hood and Cushions		
	Higher Estimate

**Evaluation:** Cabana hood and cushions are in fair condition and appearance. Soft Goods were replaced in 2015.

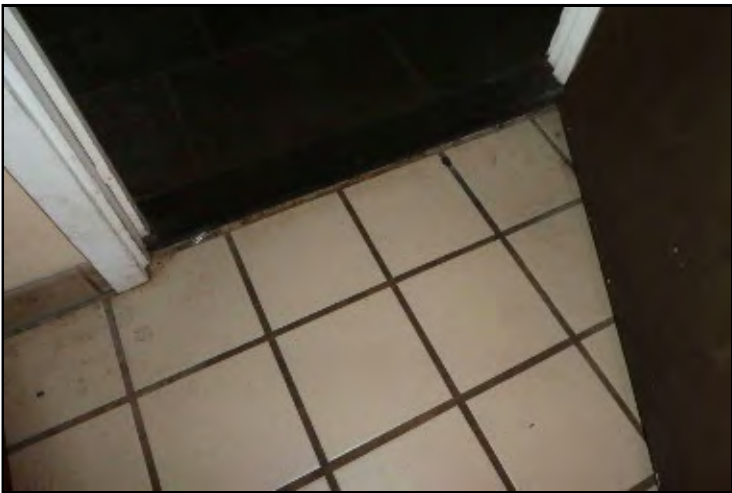
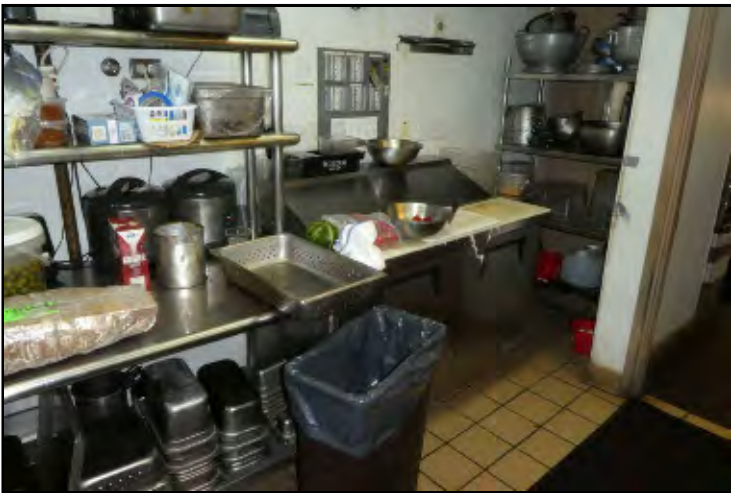
Component:	915 - Kitchen Tile - Replace	Quantity:	Approx. 900 GSF
Location:	Kitchen and Office floors		
Cost Source:	Akamai Reserves Cost Database	Useful Life:	25
Best Case:	\$22,500	Remaining Useful Life:	15
Worst Case:	\$27,000		
	\$25/GSF; Estimate to replace ceramic tile		
	\$30/GSF; Higher estimate

**Evaluation:** Tile floor is in fair condition with no reported issues. Repairs to tile and grout under the Operating Budget.

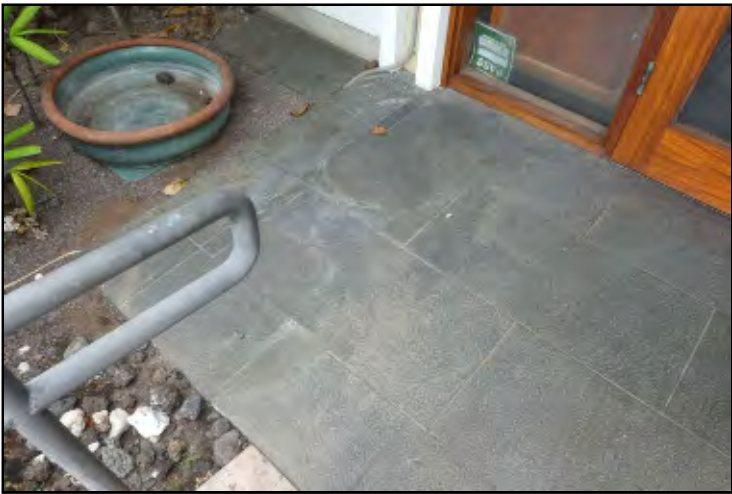
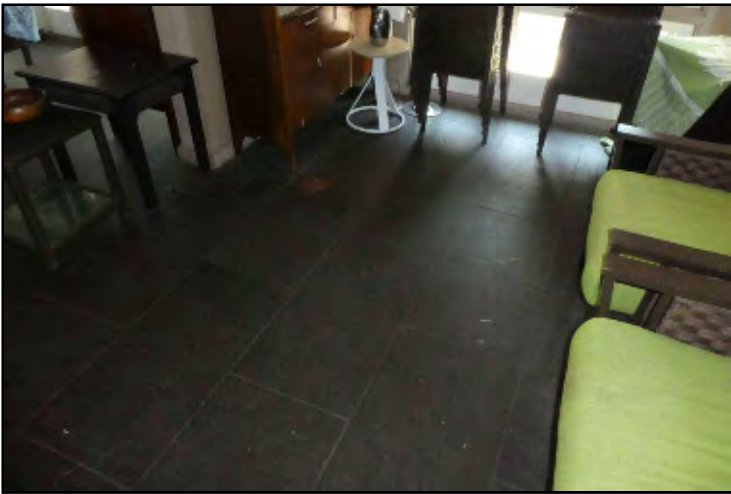
**Evaluation:** The stamped concrete floor is in fair long life condition. Expect small maintenance repairs under the Operating budget to extend the life of the component.

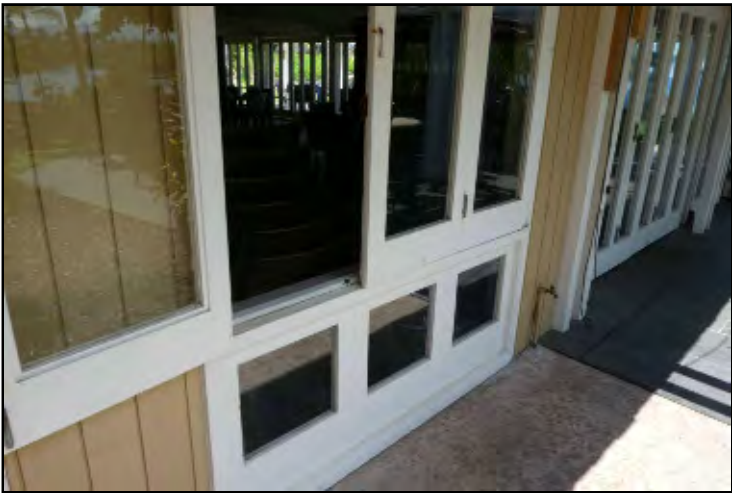
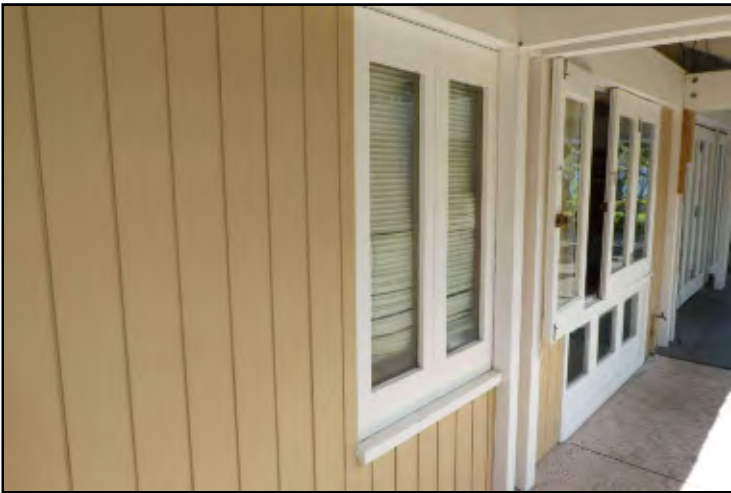
**Evaluation:** The fascia, posts, doors and trim are in fair condition. Replace wood prior to painting to extend life of component.
