# **Reserve Study Report**

## **Level I Full With-Site-Visit Study**

### **Mauna Lani Resort Association**

<b>Report</b>	<b># 1042-0</b>
<b>Prepared</b>	<b>October 12, 2018</b>
<b>Fiscal Year</b>	<b>January 1, 2019 through December 31, 2019</b>
<b>Report Expires</b>	<b>December 31, 2019</b>

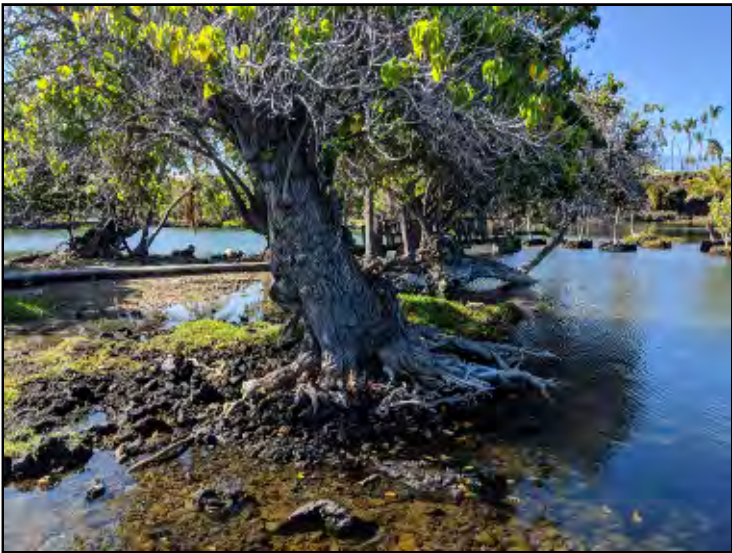
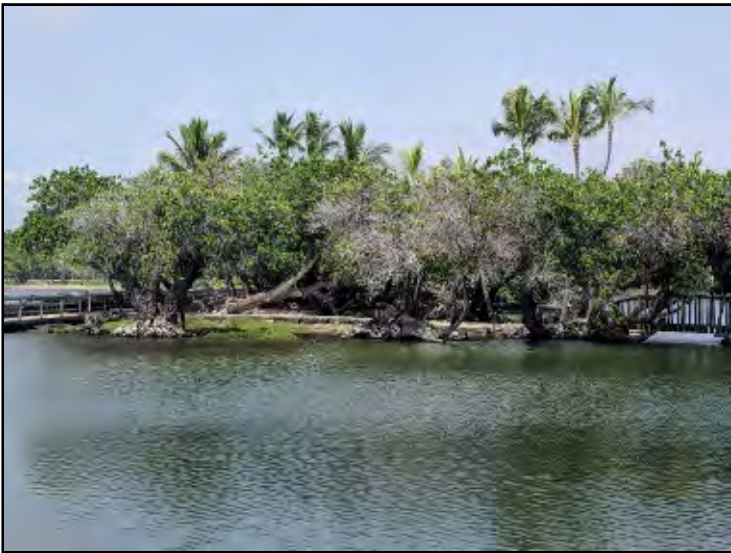
**Evaluation:** The island has seen soil loss due to King's Tides. Several trees have been lost in recent years. Approximately 270 linear foot wall will surround existing island.

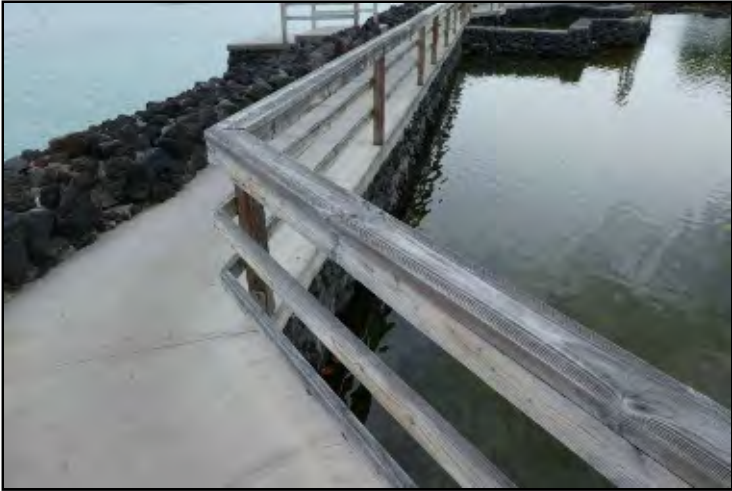
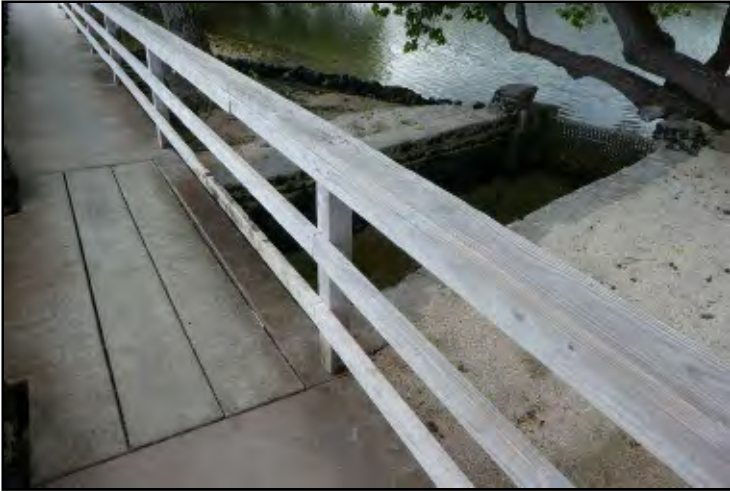
Fence is in fair condition with an aged appearance. Cost covers a sectional replacement of the fence.

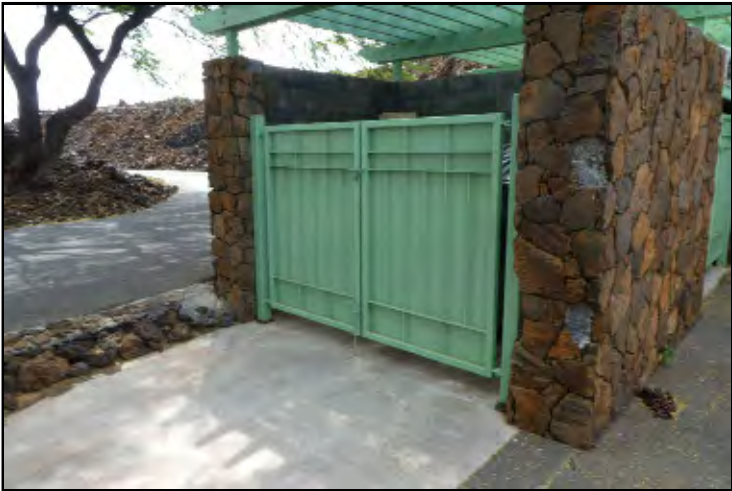
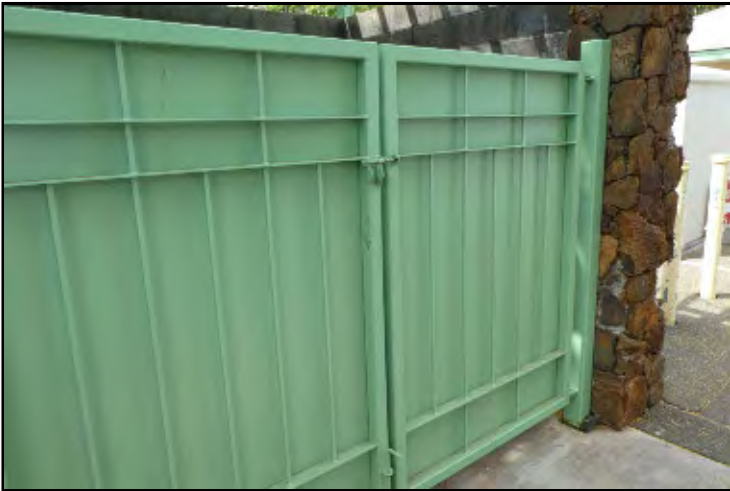
The tube steel gates are sturdy and in fair functioning condition. Minor rust and chips indicate frequent repainting is necessary.

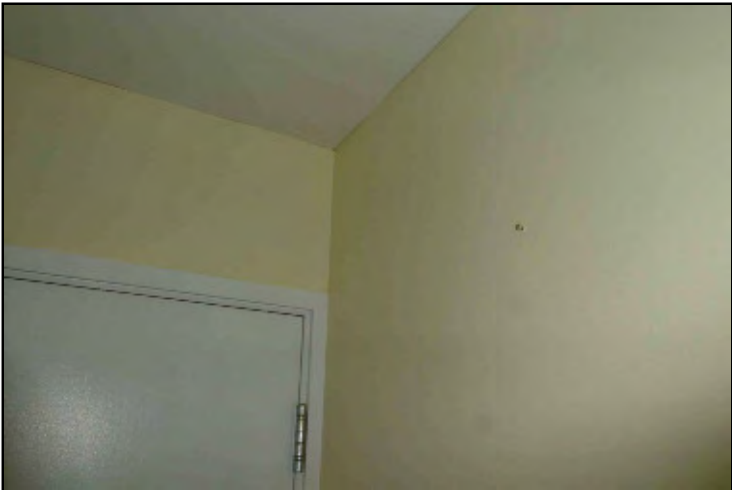
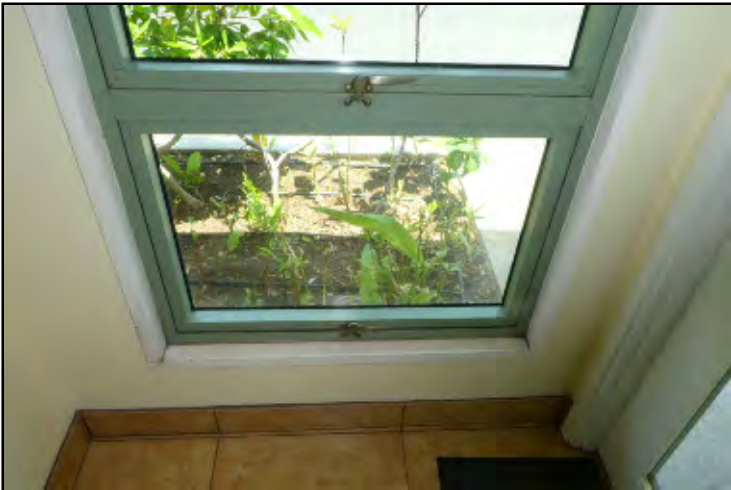
Evaluation: Painted surfaces are in good appearance and condition. Was painted in 2017.

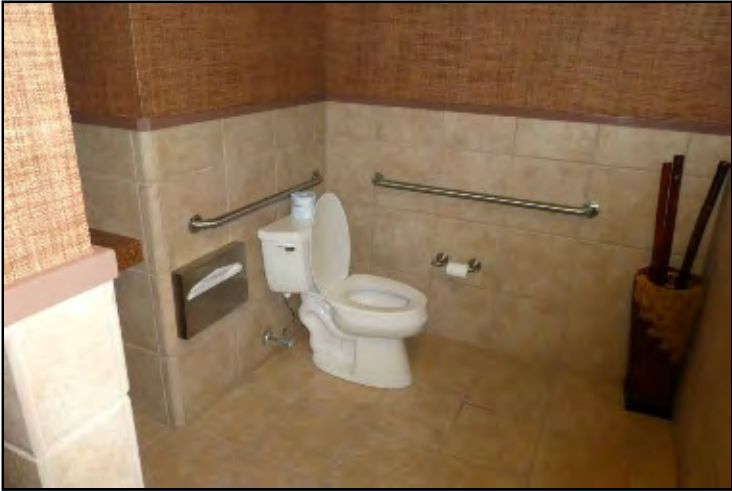
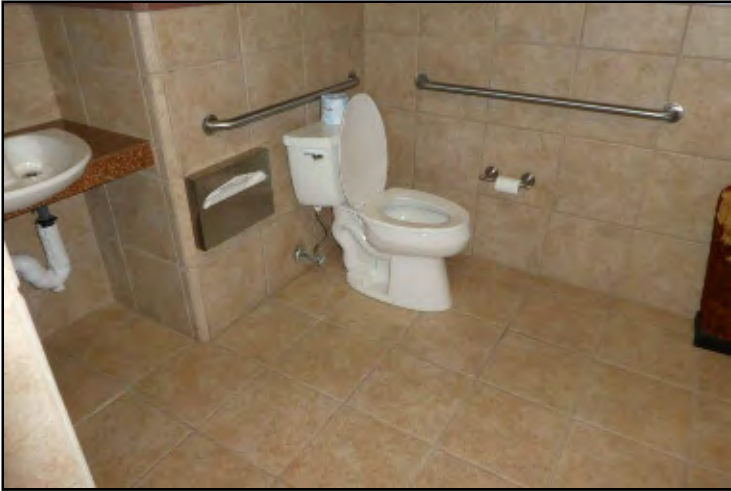
**Evaluation:** Tile floors and half walls, wallcovering and newer fixtures give an attractive appearance.

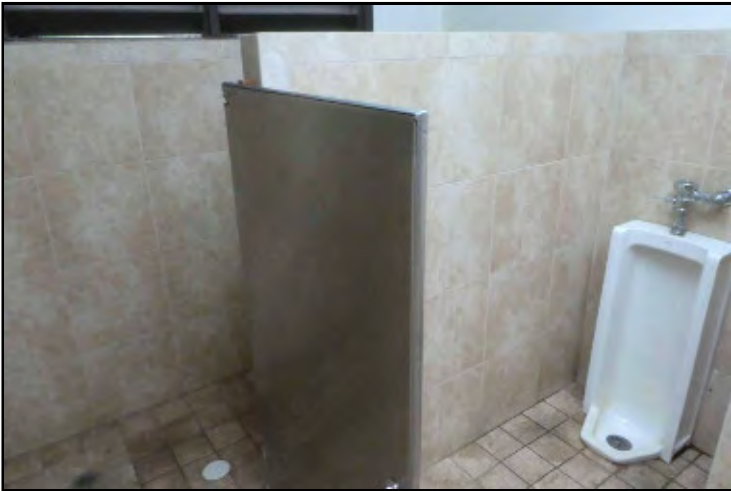
**Evaluation:** The wall mounted fixtures, accessories and minimal paint are in fair condition.

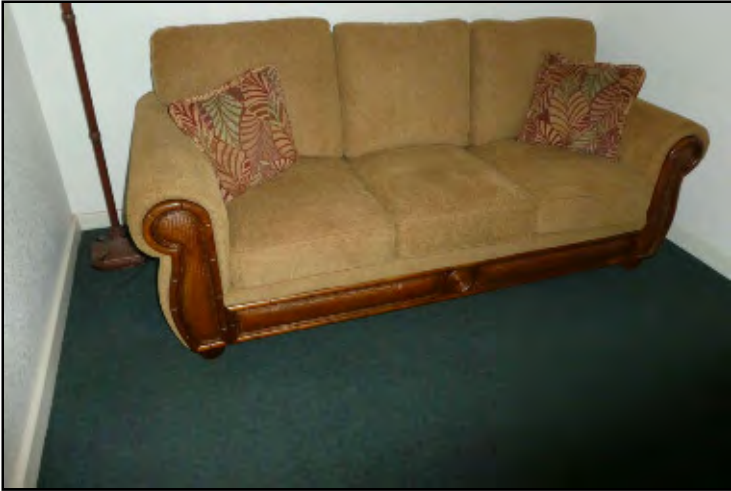
713 - Carpet - Replace

Evaluation: Carpet is in fair condition and appearance.

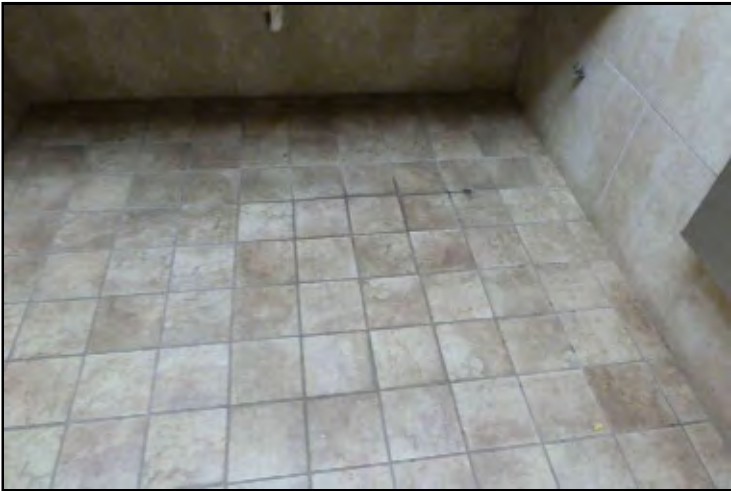
714 - Public Restroom Tile Floor - Replace

Evaluation: Ceramic tile is in fair condition with minor staining and grime. Eventual full replacement to contemporary decor anticipated.

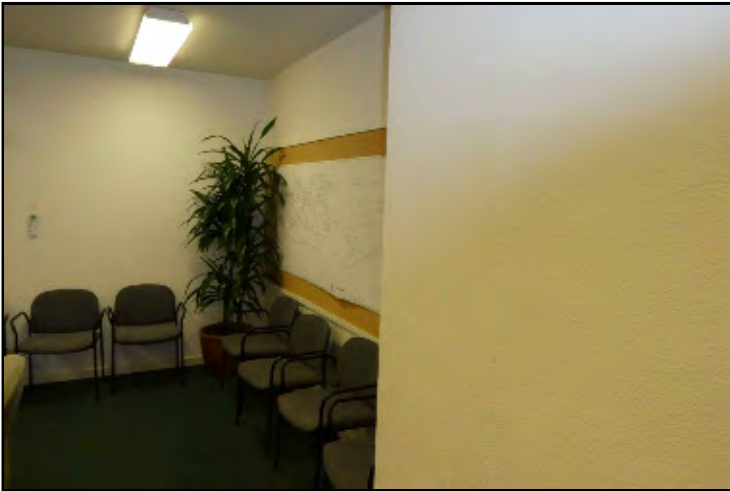
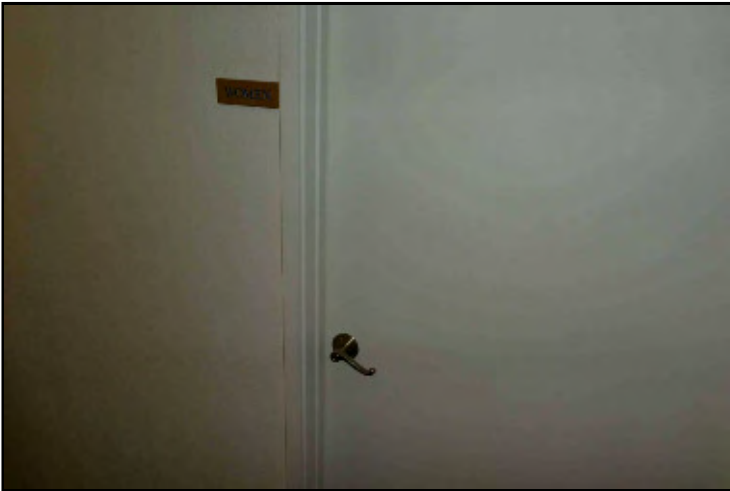
**Evaluation:** Painted surface is in fair condition and appearance.

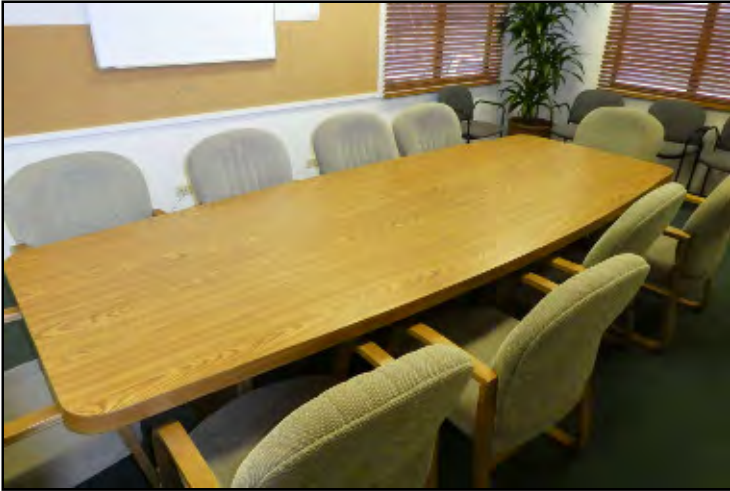
775 - Conference Room Furniture - Replace

**Evaluation:** Wood frame cushioned chairs and conference table are in fair condition.

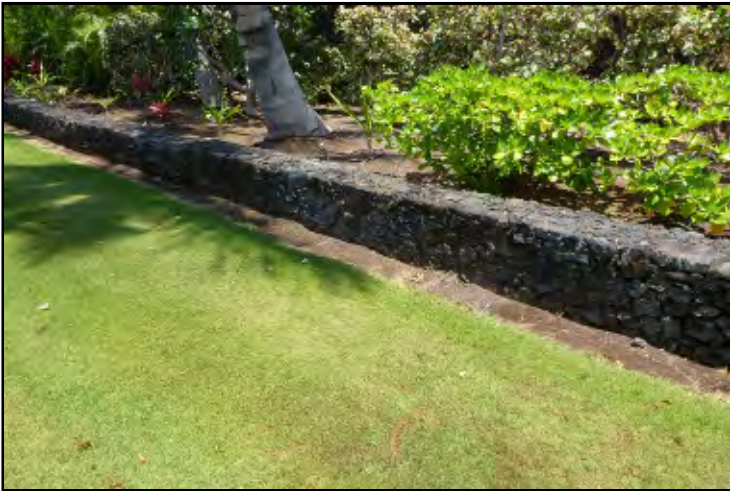
902 - Irrigation Control System - Replace

**Evaluation:** Extensive irrigation system maintained by outside contractor under Operating Budget. Wireless control system hardware and software are Reserve components.

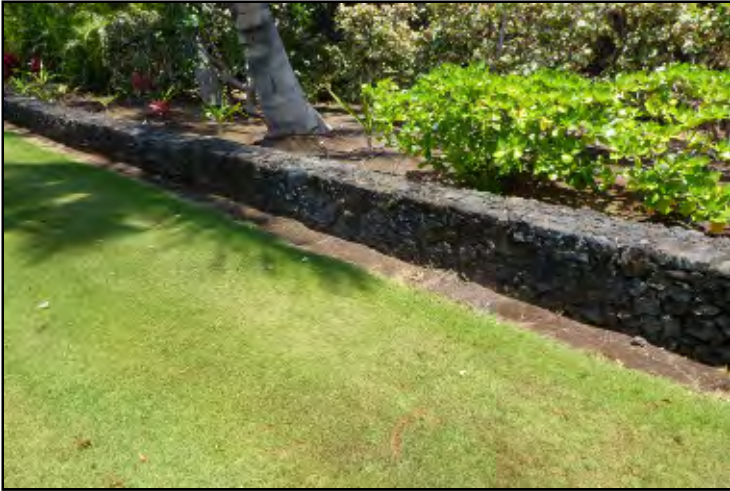
902 - Irrigation System - Repair/Replace

Evaluation: Extraordinary repairs, replacements, and retrofits of irrigation equipment have occurred on this cycle.

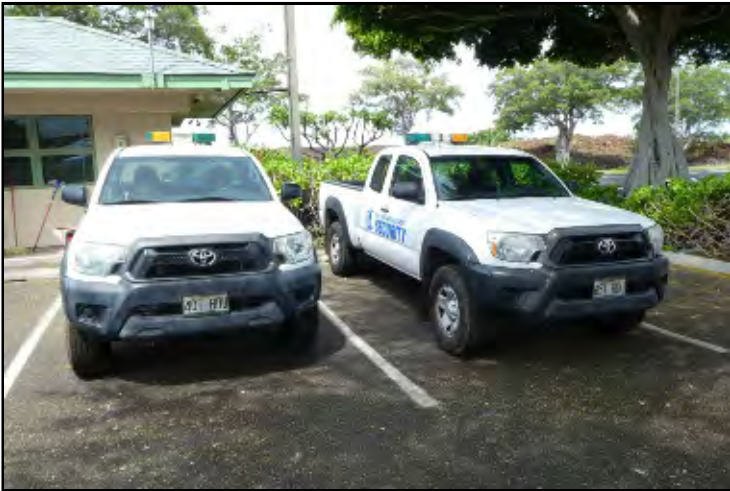
921 - Security Pick Up Trucks - Partial Replacement

Evaluation: One Toyota Tacoma X Cab was replaced in 2017 and is in good condition for security guard operations. Two more are due to be replaced in 2019. Used trucks are turned over to the maintenance and landscape operations.

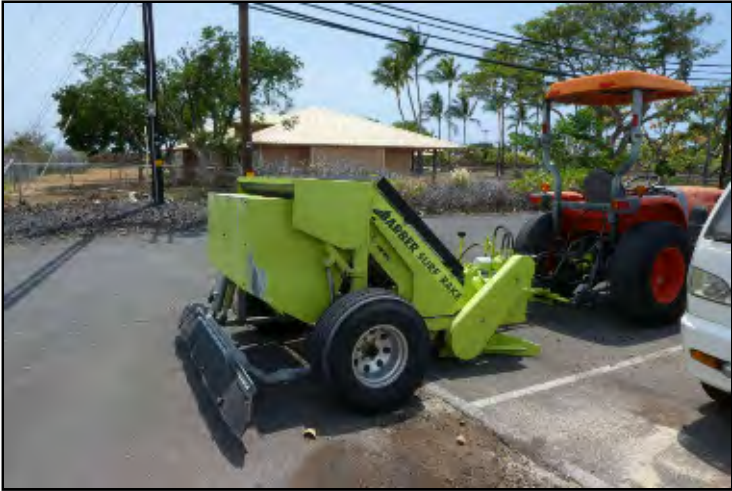
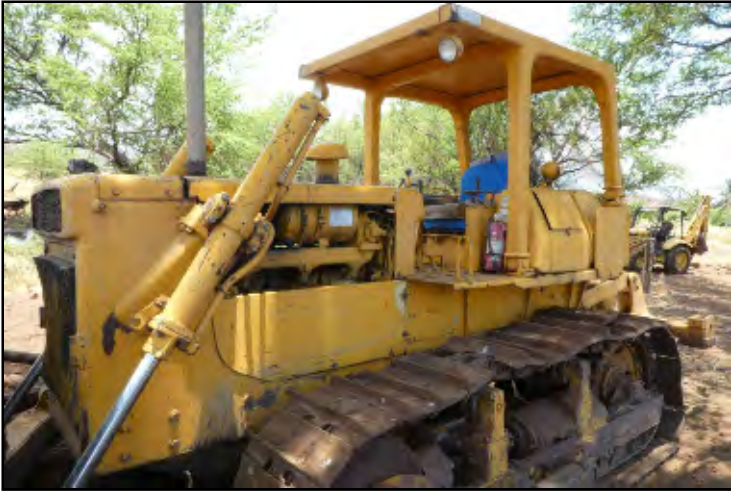
936 - Heavy Equipment - Partial Rebuild/Replace

**Evaluation:** This is a budget to rebuild or replace individual units. Inventory includes: Beach groomer, Kubota Tractor, Dozer, (2) Chippers, Forklift, Sweeper, trailers.

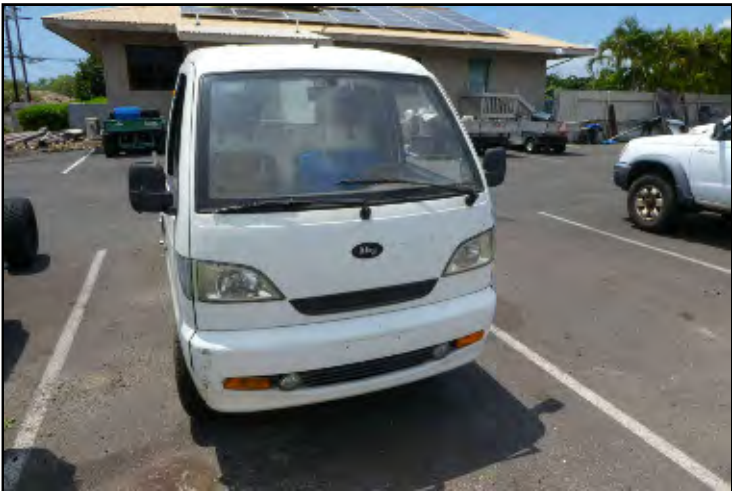
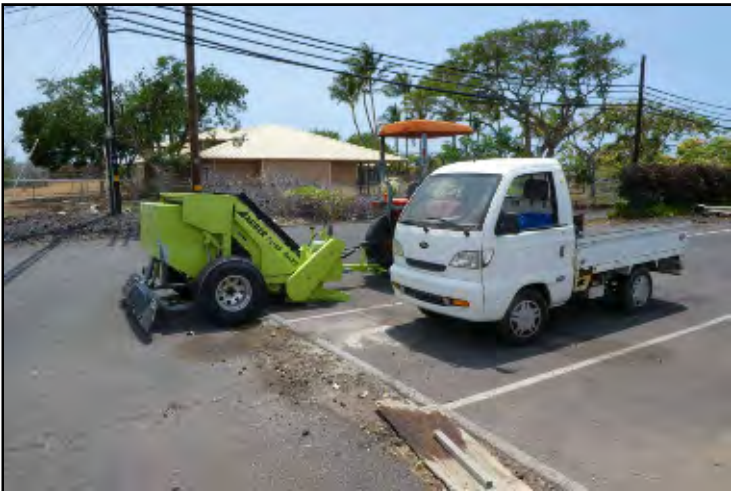
940 - Utility Carts - Partial Replace

**Evaluation:** Carts with and without beds are in varied condition. As the carts age they are moved to task that make them less visible to the public. Expect to replace 2 carts on this schedule to maintain good condition appearance.

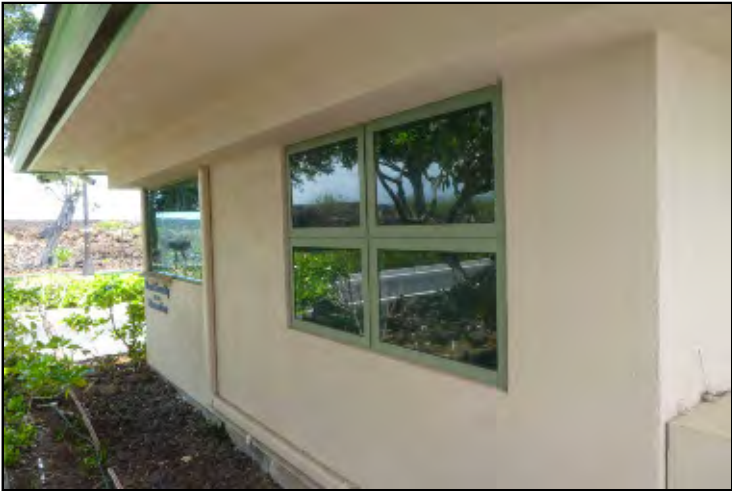
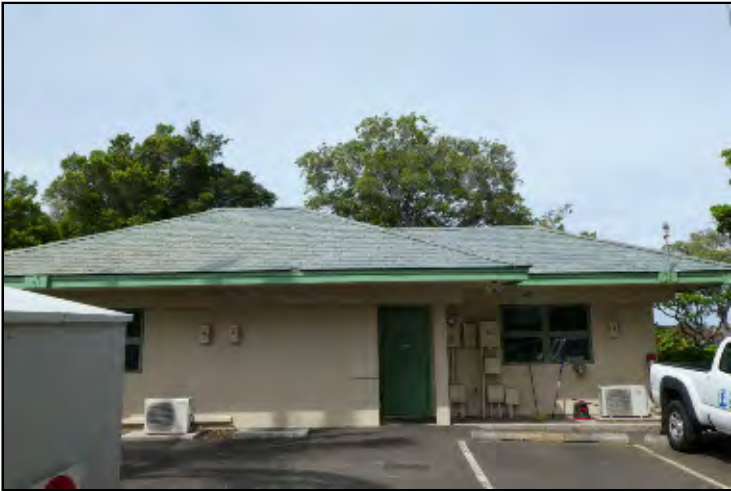
Evaluation: Exterior is in fair condition and appearance.

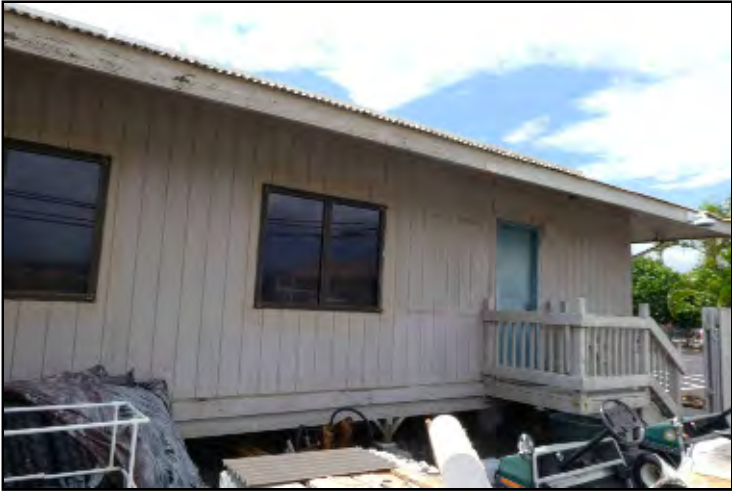
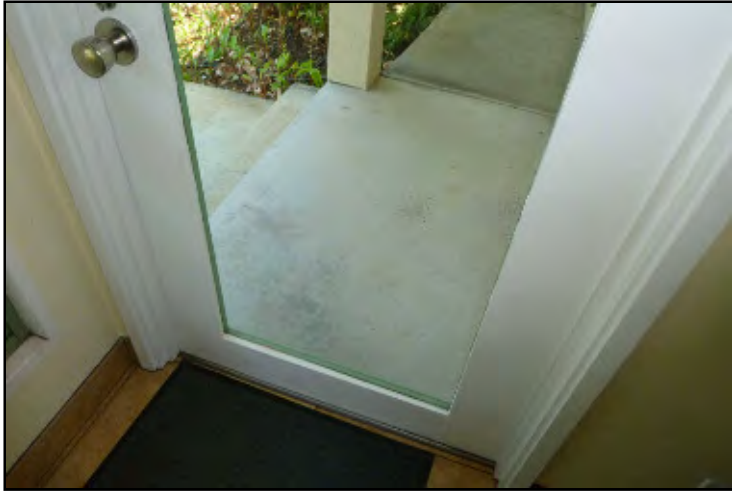
**Evaluation:** Generally, in fair condition and appearance. Repaint all buildings at same time for consistent appearance.

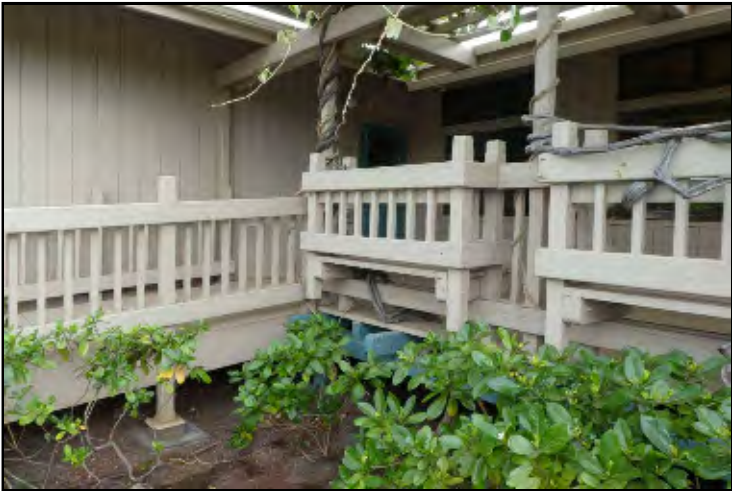
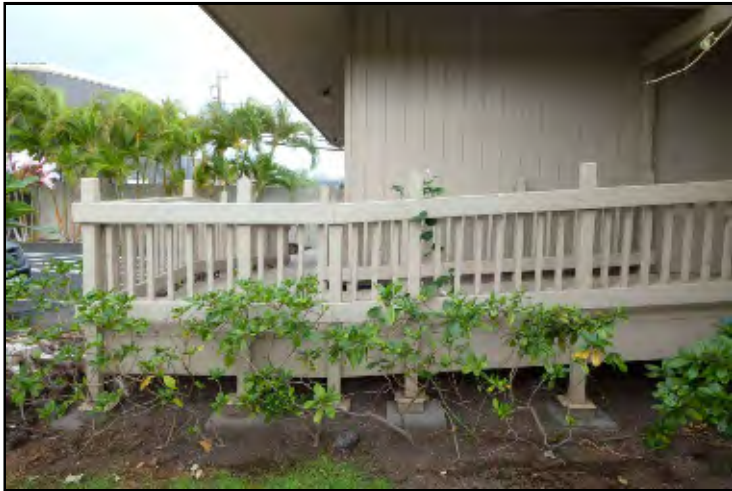
**Evaluation:** Deck installed in 2012 and is in fair condition.

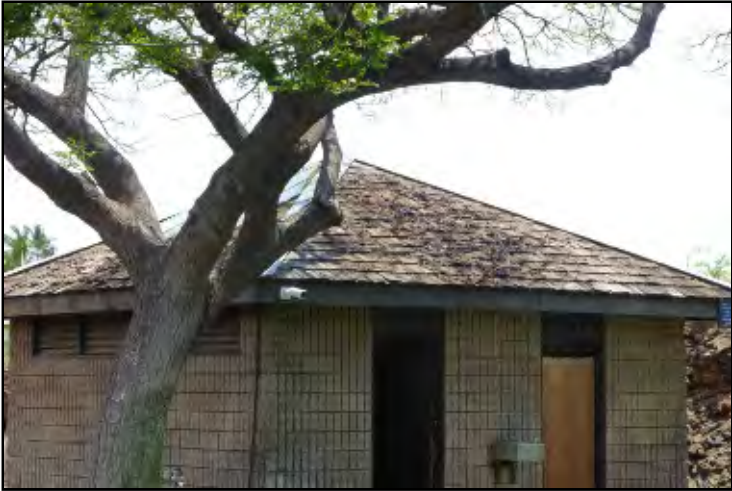
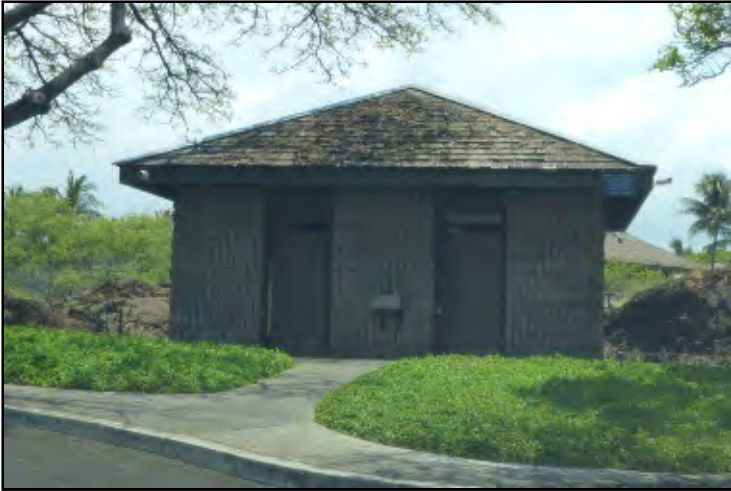
1105 - Park Restroom Roof - Replace

**Evaluation:** Shingles are curled, dry and deteriorated for a poor condition. Recommend replacing with standing seam copper or cement tile for long life fire resistant roof.

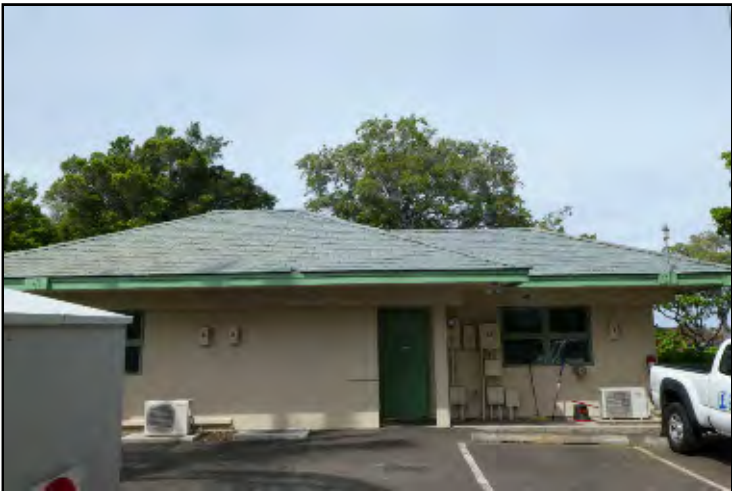
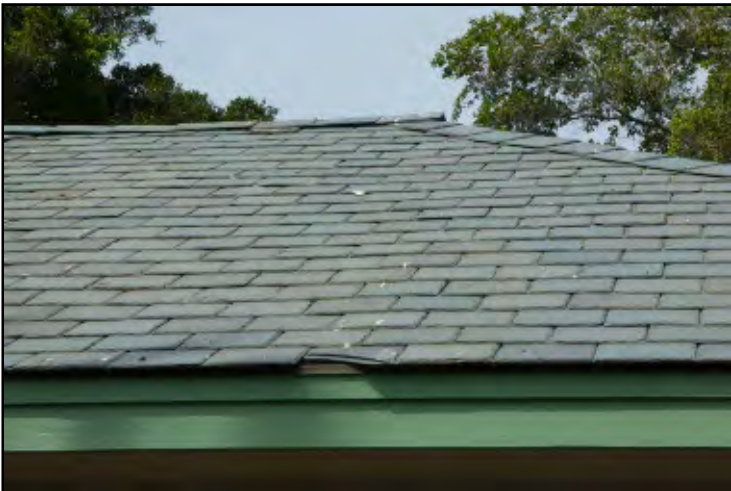
1108 - Security Tile Roof - Replace

**Evaluation:** Slate tiles are in fair appearance condition. Nearing replacement time of dried out deteriorated underlayment. Expect to remove tile, replace underlayment, install new flashings and re-install tile.

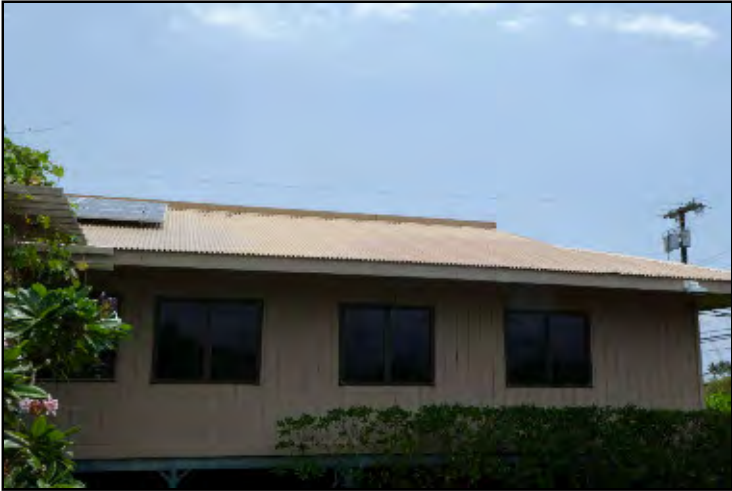
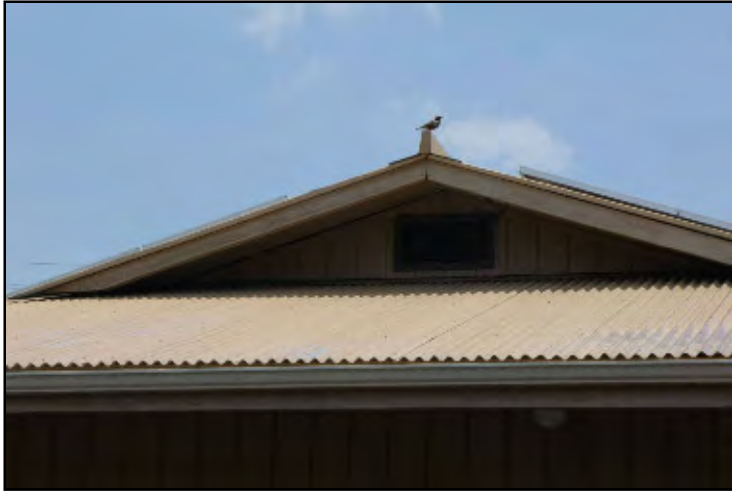
**Evaluation:** Reported plan to seal roofs to protects metal, prevents leaks, and extend remaining life of metal roof replacement.

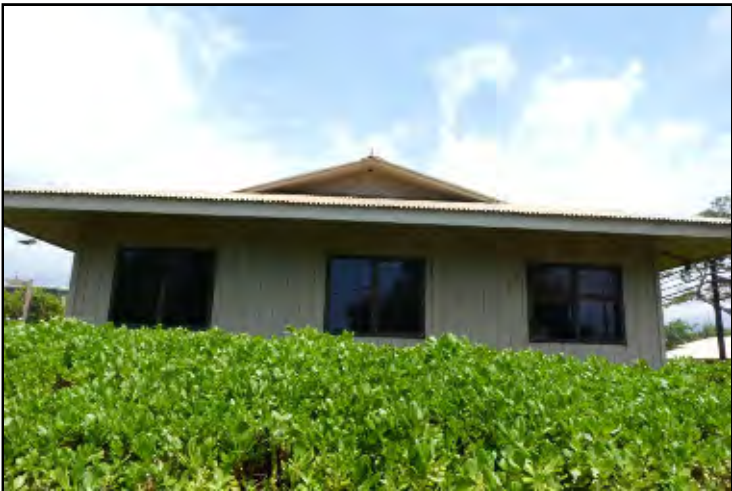
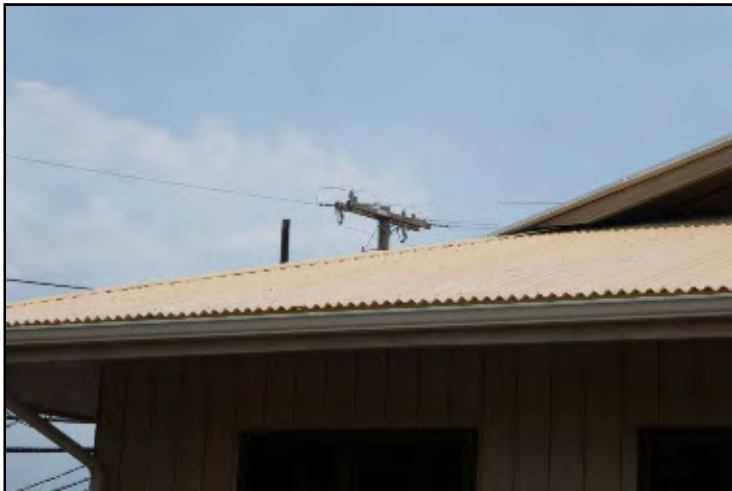
**Component:** 1110 - Administration Metal Roof - Replace/Repair

**Evaluation:** Aged fair condition with no reported leaks.

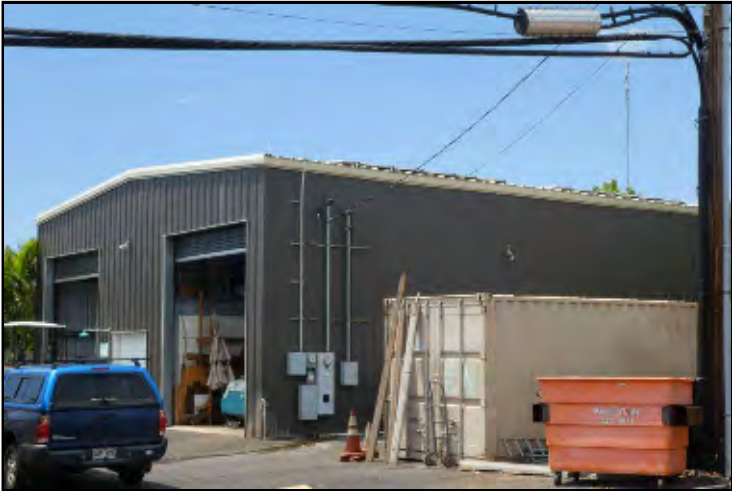
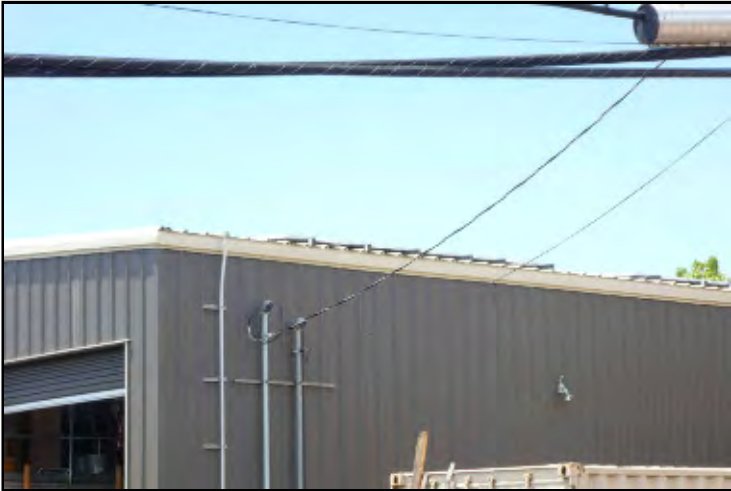
**Evaluation:** Unable to inspect roof. No reported leaks. Assessment is based on reported age.

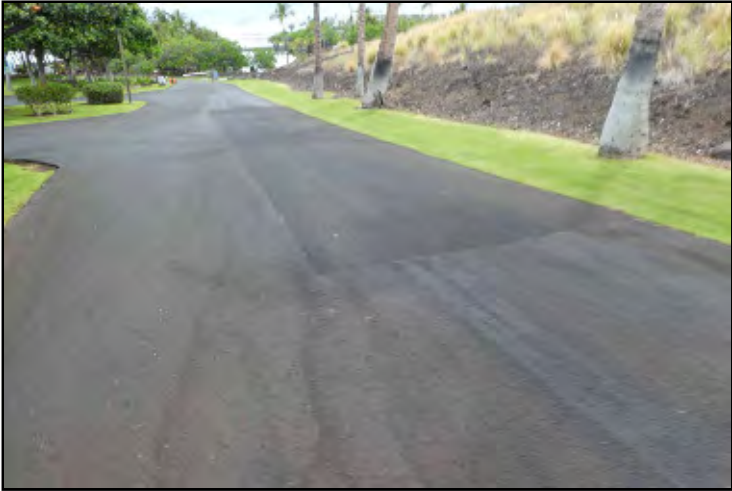
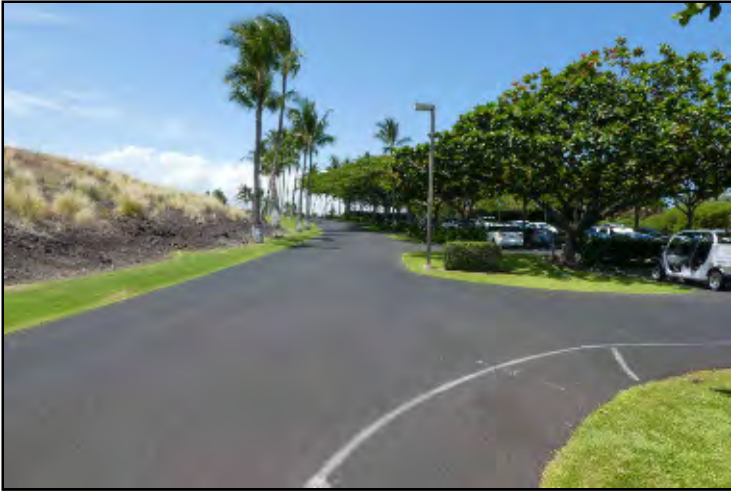
**Evaluation:** The surface is in level fair condition in general. Sectional replacement of damaged asphalt completed recently.

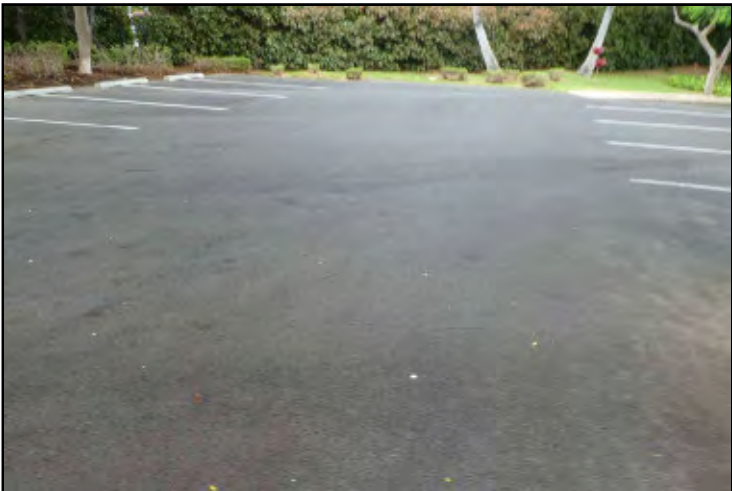
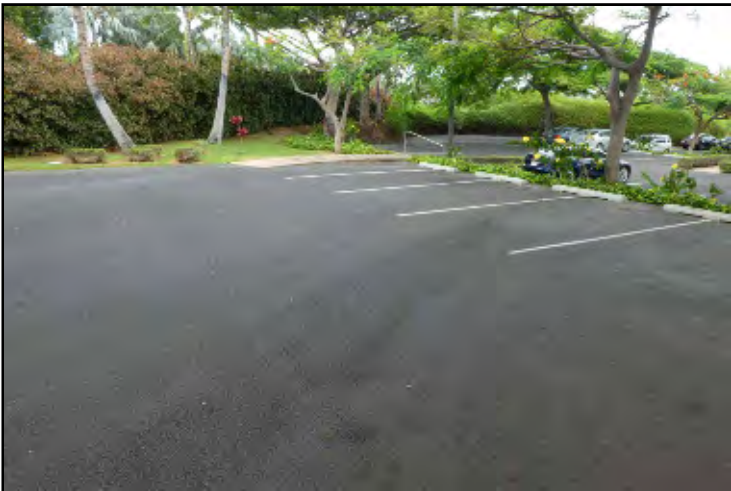
**Evaluation:** The surface is in level fair condition in general. Some noted water stains from irrigation run off.

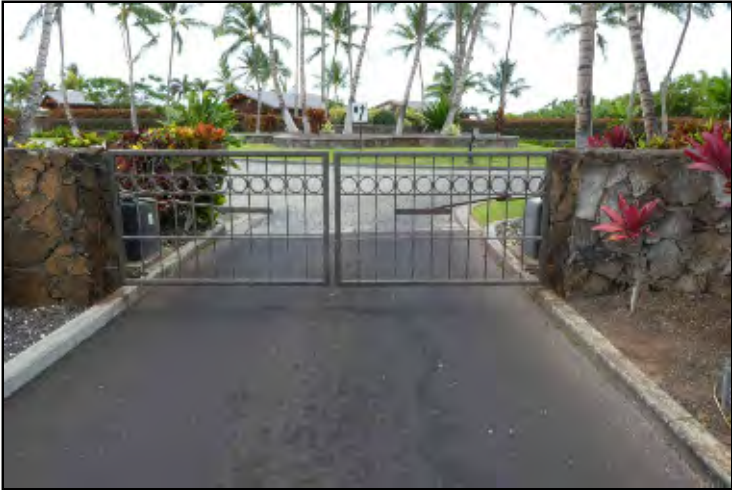
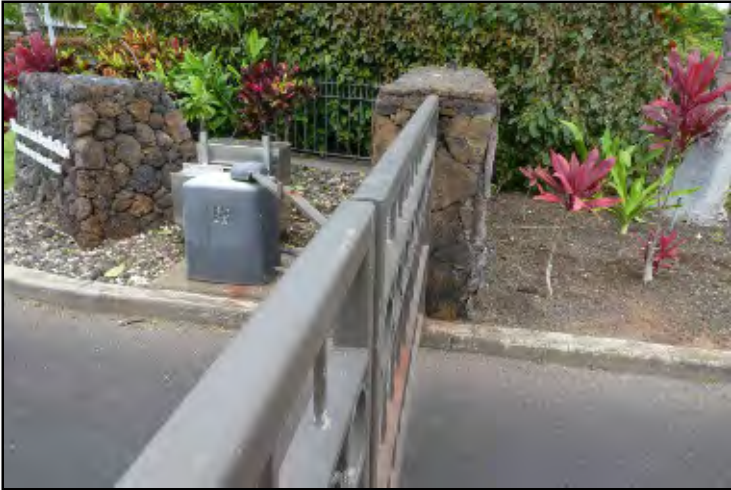
**Component:** 320 - Metal Gates - Replace

**Evaluation:** The gates are in fair functioning condition. Paint coverage is full and in fair condition. Frequent repainting and lubrication of hinges under the Operating budget will extend the life.

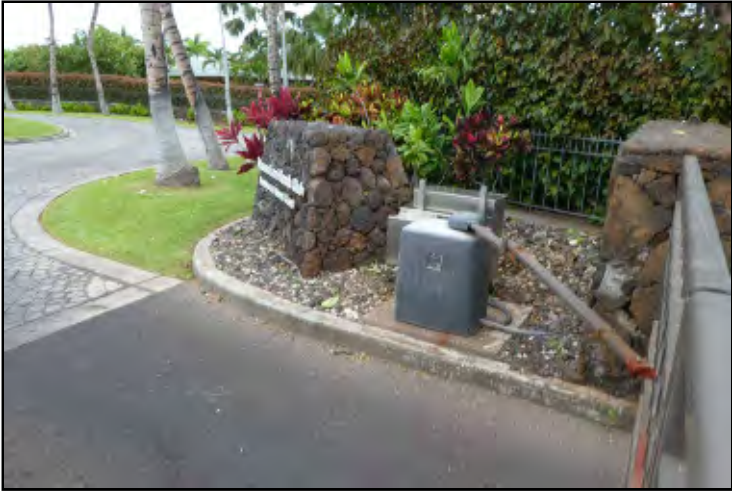
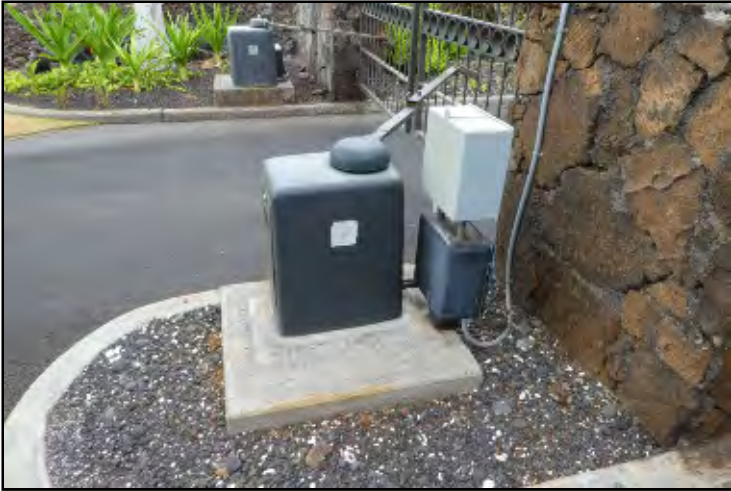
**Evaluation:** These units are in fair functioning condition. The operating arms are showing minimal corrosion, wear and water stain. The units are experiencing extended life.

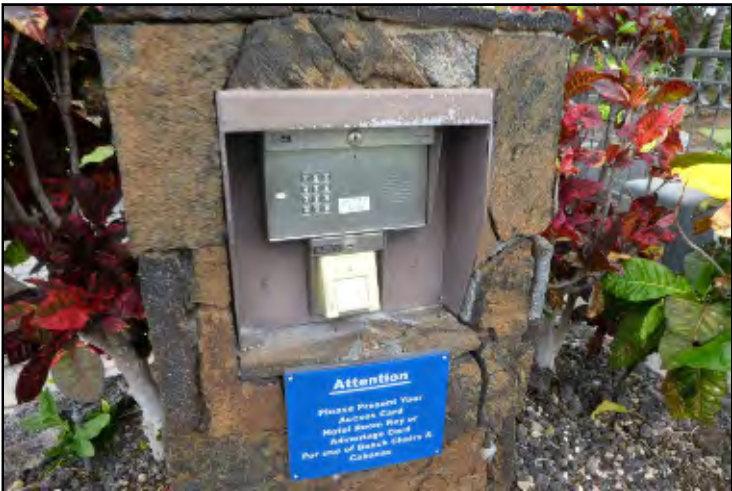
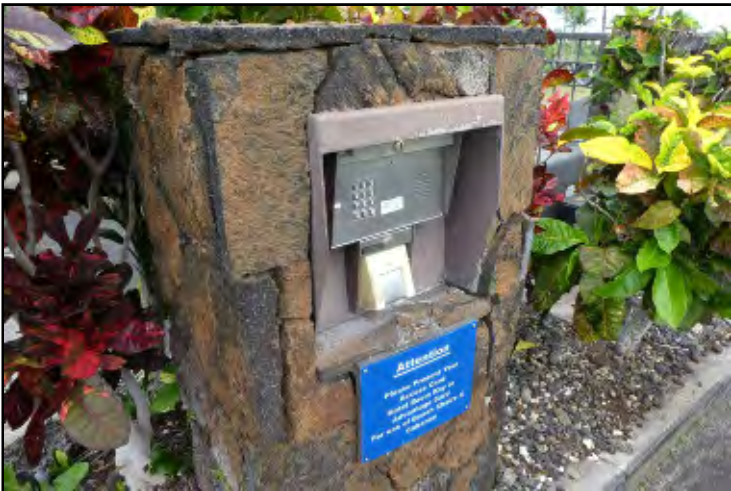
Component:	402 - Intercom/Card reader - Replace	Quantity:	1 Station
Location:	Adjacent to entry gate		
Cost Source:	Estimate provided by client	Useful Life:	10 Remaining Useful Life:0
Best Case:	\$40,000		Estimate installed
Worst Case:	\$44,000		Higher estimate for parts or installation

**Evaluation:** Entry System is in aged, but fair and functioning condition. New system scheduled to be installed August 2018.

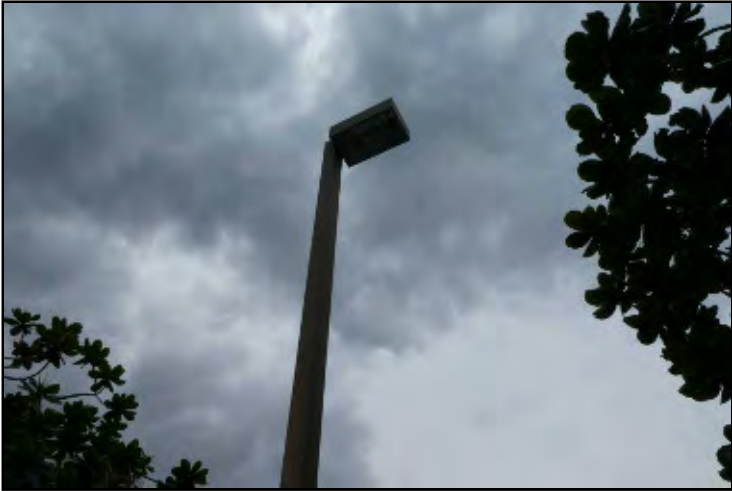
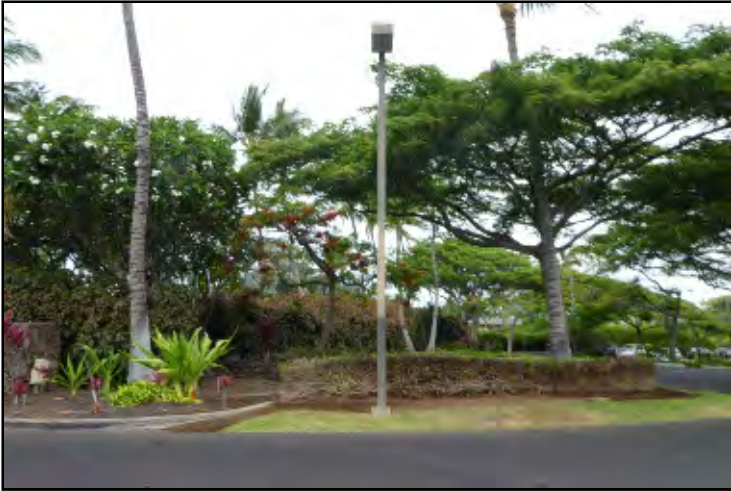
**Evaluation:** The lights are in fair functioning condition. Periodic cleaning and coating of anchor bolts and repairs to the base covers will extend the life of the units. Cost is to replace three of the nine total pole lights.

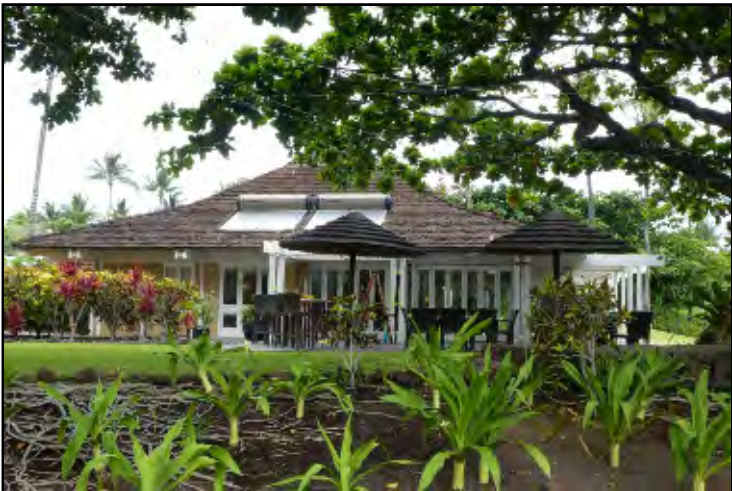
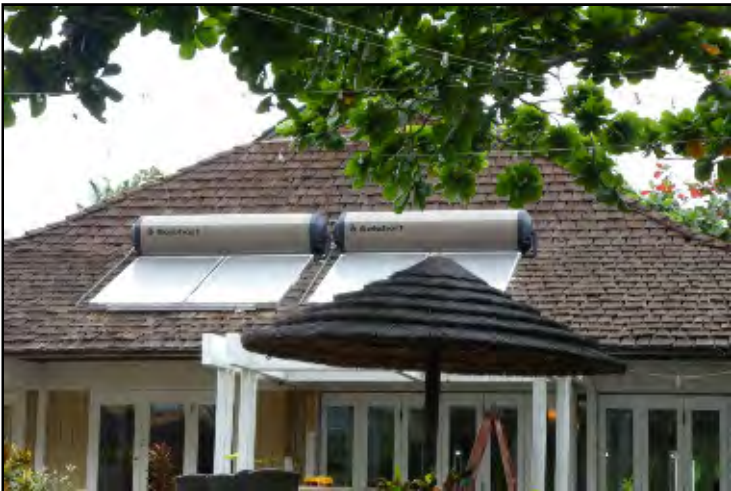
**Evaluation:** The 2 integrated tank and panels are in fair functioning condition. Recommended changing annular rod at least every 3 years and flushing the tank annually to extend the useful life.

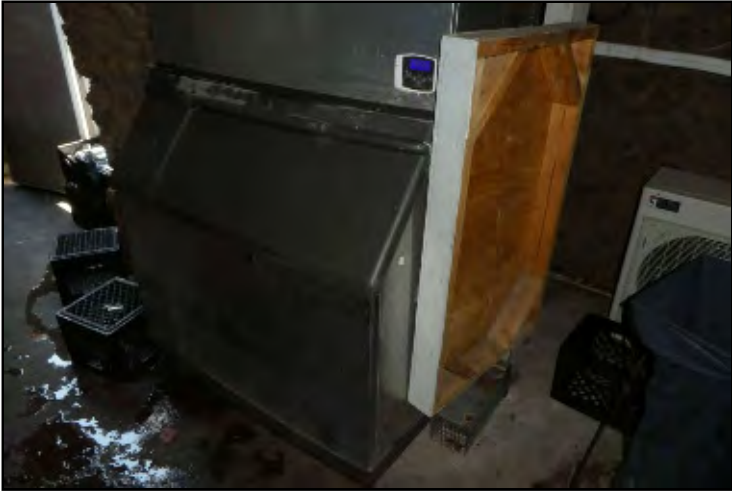
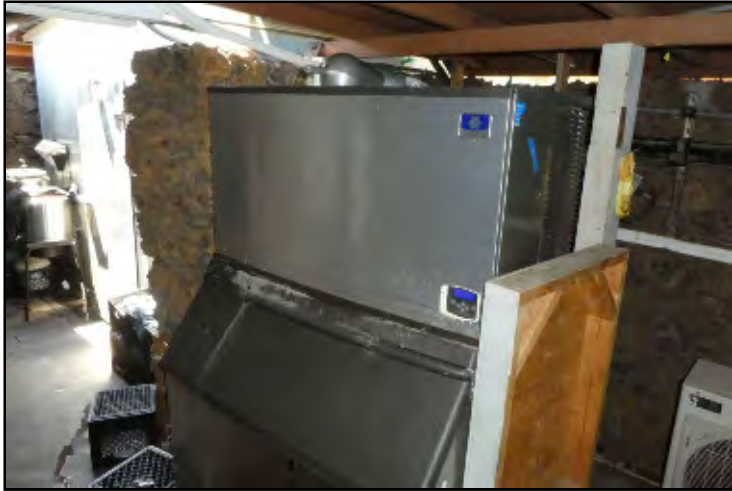
717 - Ice Machine- Replace

The ice unit was installed in 2013 and repaired in 2017. Reported to be in good functioning condition.

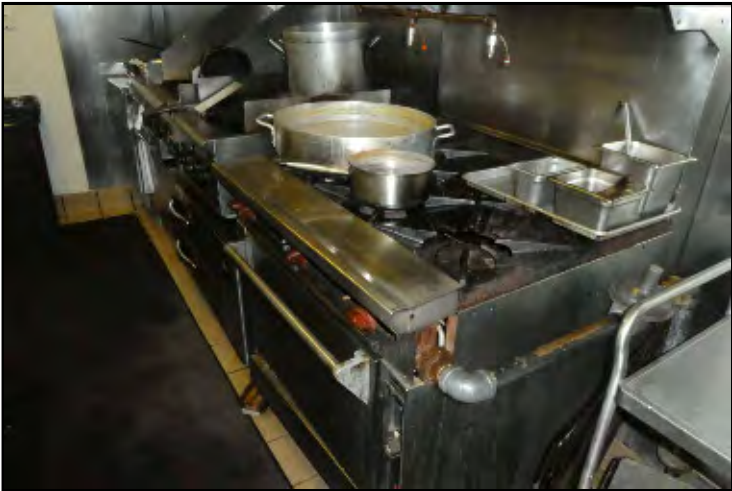
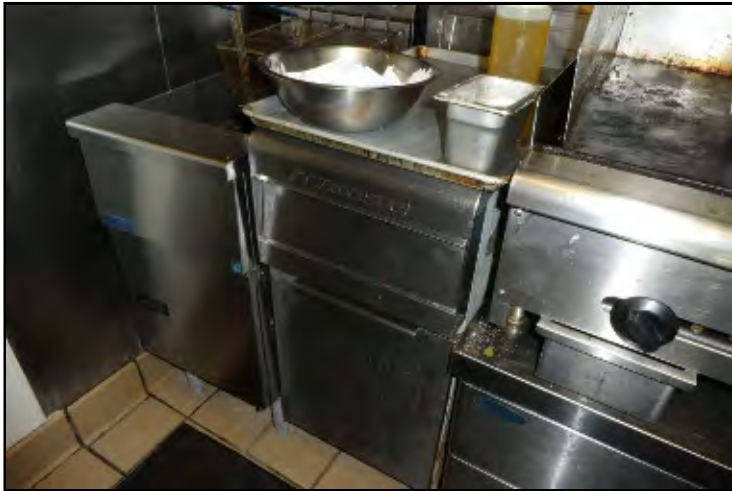
717 - Kitchen Appliances - Partial Replace

Dishwasher, gas range, gas broiler, deep fryer, ovens, small under counter refrigerators, fume hood, garbage disposal and salad prep area appear in fair aged condition. Cost is for partial replacement of Kitchen Appliances.

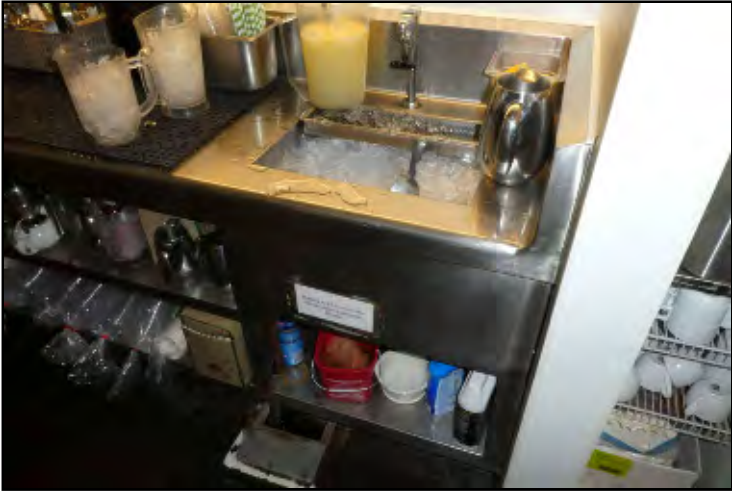
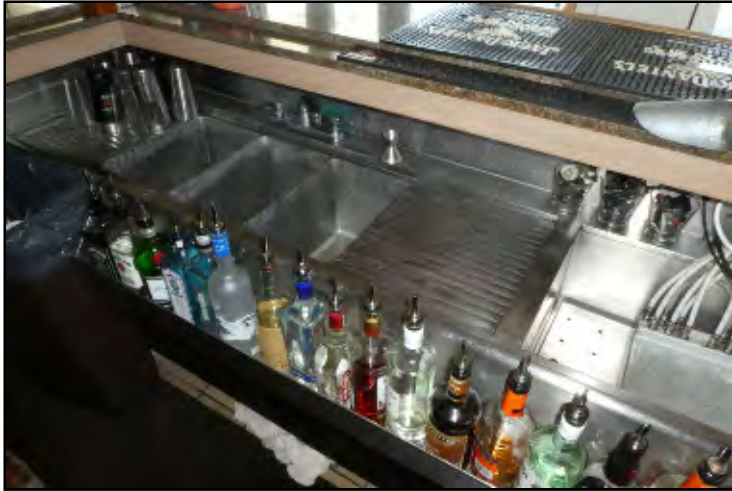
**Evaluation:** These older appliances are in fair aged condition. The waiters sink and counter is in scratched aged condition. The bar area refrigerator, wash sink bottle station, and counters are in similar fair and aged condition.
