# **Reserve Study Report**

## **Level I Full With-Site-Visit Study**

### **Mauna Lani Resort Association**

<b>Report</b>	<b># 1042-0</b>
<b>Prepared</b>	<b>October 12, 2018</b>
<b>Fiscal Year</b>	<b>January 1, 2019 through December 31, 2019</b>
<b>Report Expires</b>	<b>December 31, 2019</b>

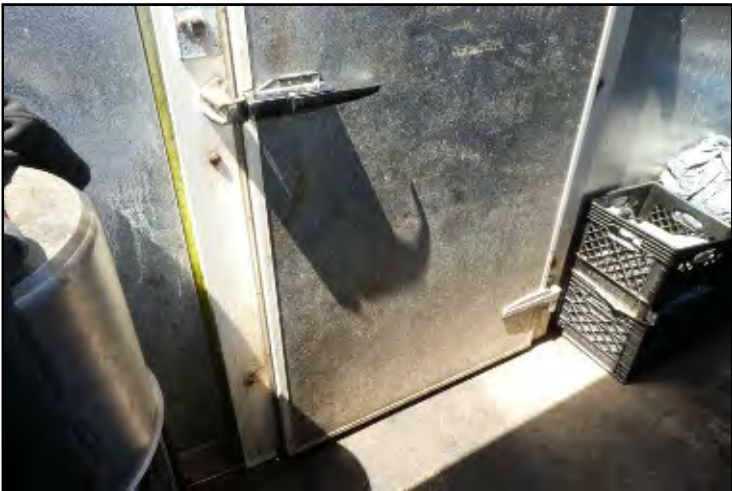
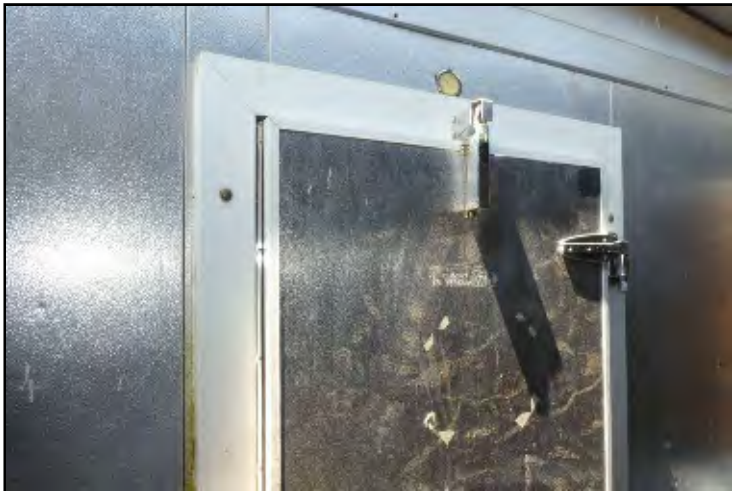
**Evaluation:** The 12x10x8ft high insulated sheet metal enclosure is in aged fair functioning condition. Repairs completed in 2017.

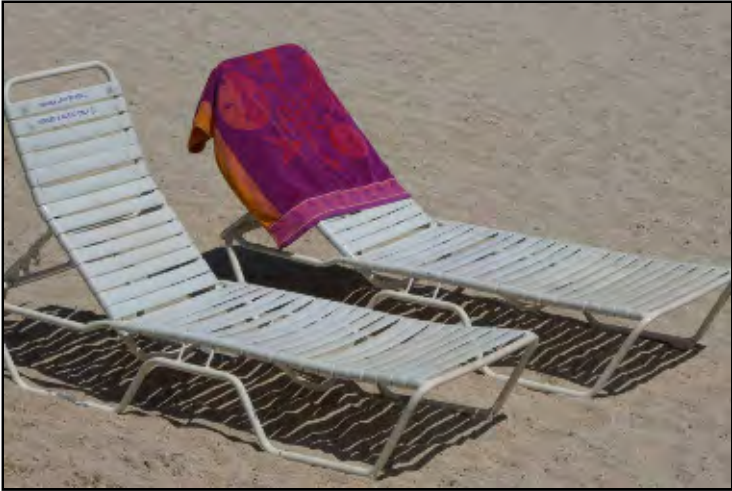
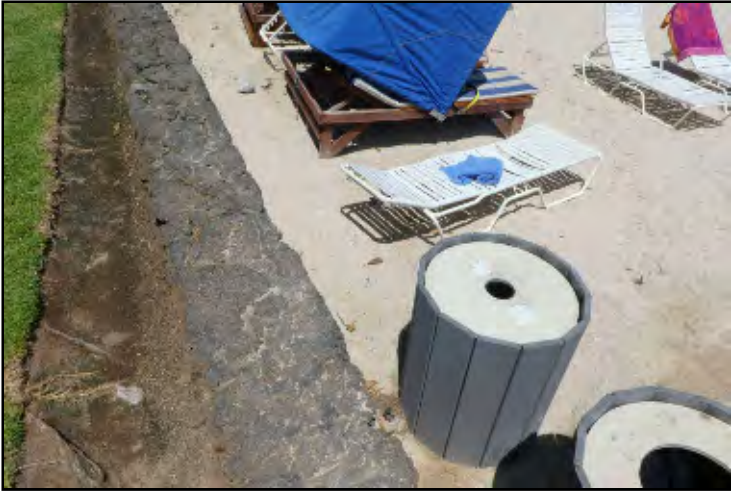
**Component:** 718 - Chaise Lounges - Replace  
**Location:** Beach at Makaiwa Bay  
**Cost Source:** Client Cost History  
**Best Case:** \$21,000      Cost to Replace Lounges  
**Worst Case:** \$28,000      Higher Cost

**Evaluation:** Chaise Lounges are in good appearance and condition. Lounges were replaced in 2017.

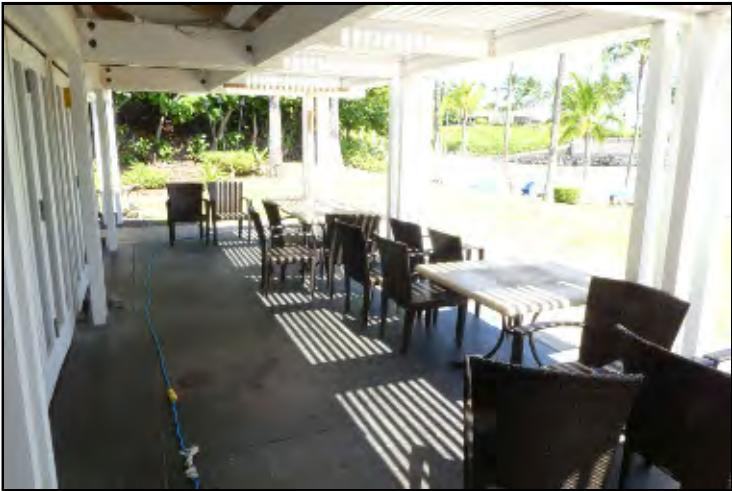
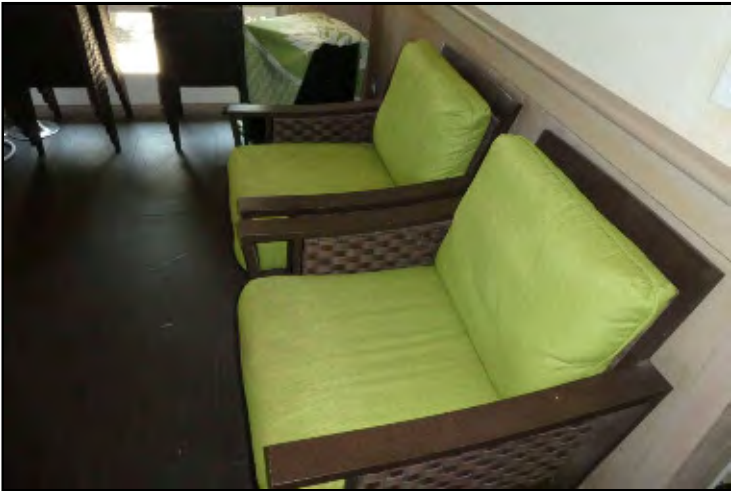
**Component:** 718 - Restaurant Furniture - Replace  
**Location:** Bar, Dining Room, Lanai, and Sitting Area  
**Cost Source:** Akamai Reserves Cost Database  
**Best Case:** \$50,000      Estimate to replace with similar pieces  
**Worst Case:** \$56,000      Higher estimate

**Evaluation:** The furniture is in fair condition and appearance. Some of the furniture is exposed to sunlight on the lanais and will age faster than the protected inside furniture. The assumption is that the furniture will be rotated to maintain a consistent appearance.

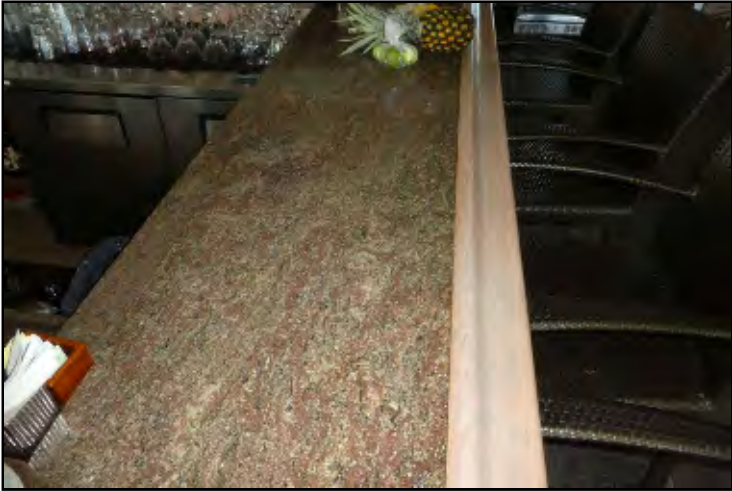
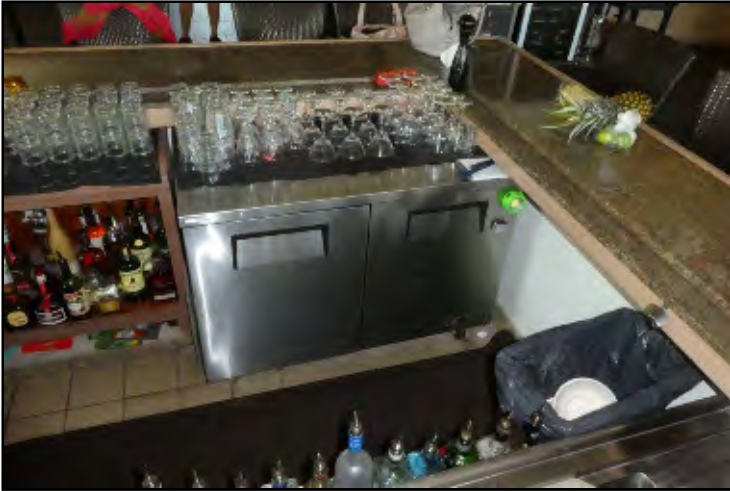
**Evaluation:** The bar top installed in 2009 with granite is in fair condition and appearance.

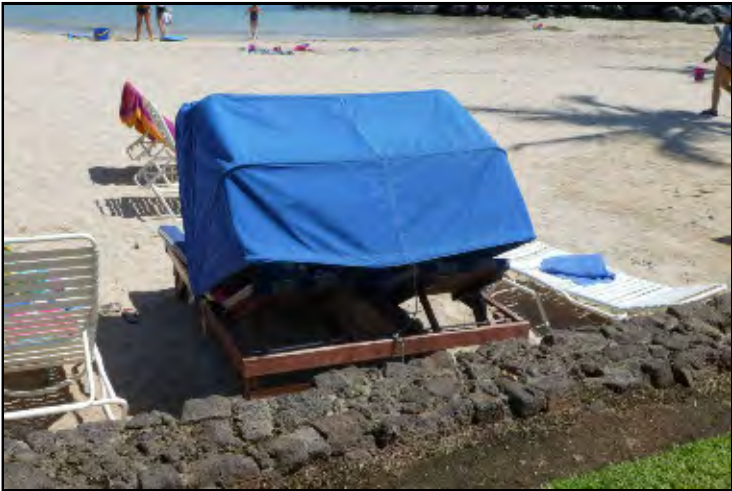
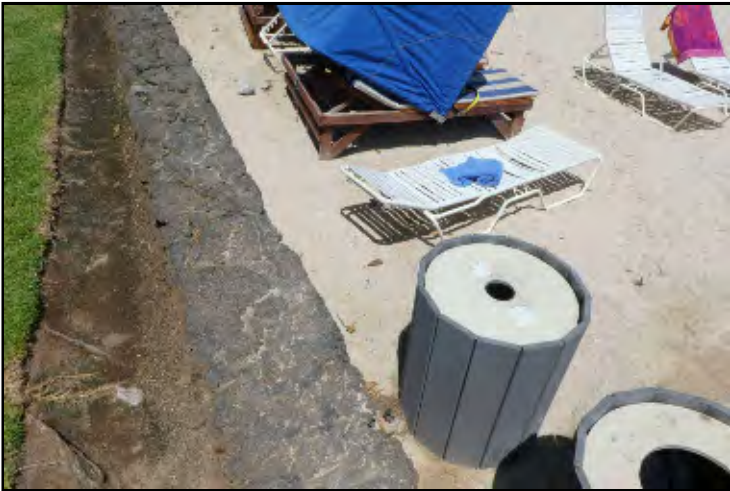
**Evaluation:** Cabanas are in fair condition and appearance. Cost only includes the frame of the Cabanas and not the hood or cushions. Cost is unknown at this time.

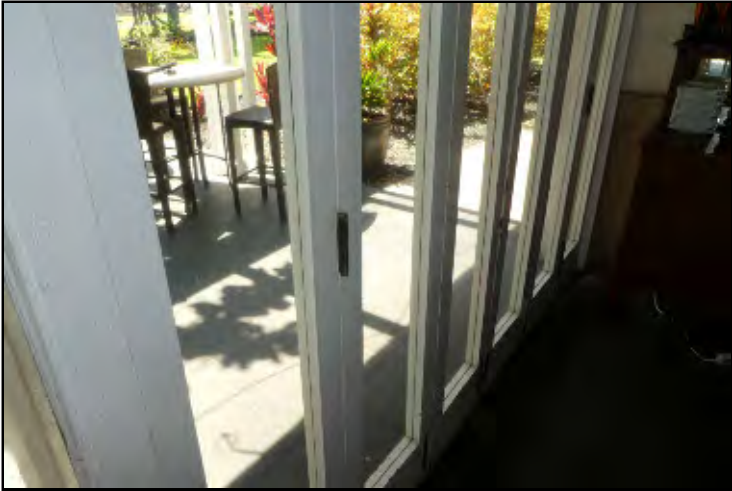
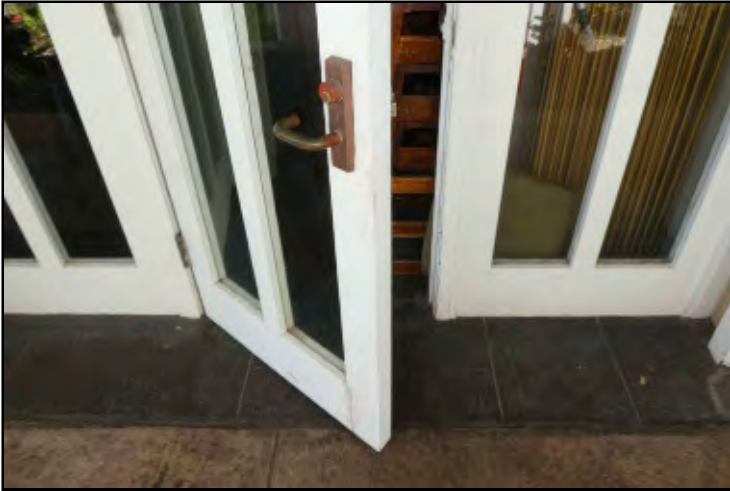
**Evaluation:** The numerous wood frame and glass doors are in fair aged condition. Minor repairs to doors recently completed. Expect to make minor repairs and replace hardware as needed as maintenance under the Operating Budget.

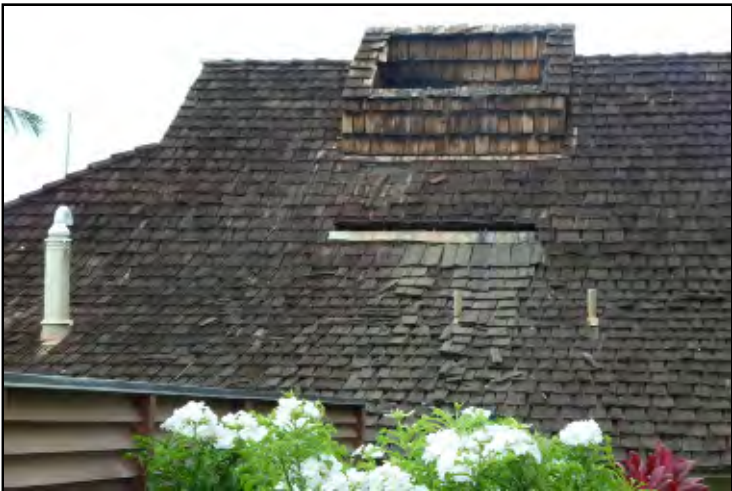
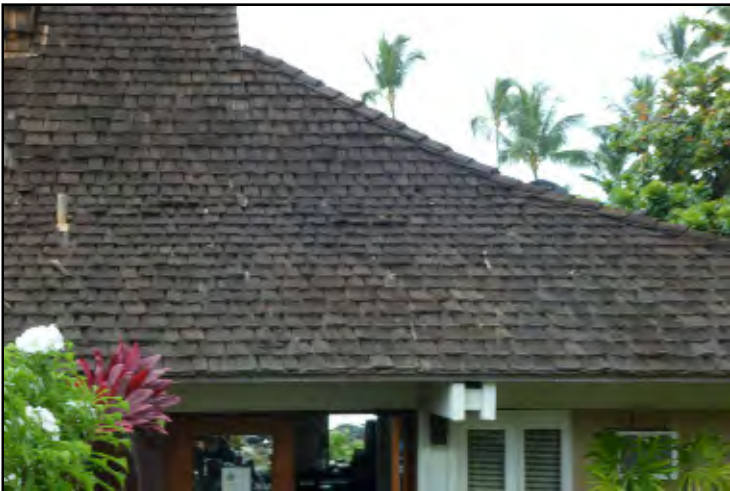
**Evaluation:** The re-sawn cedar shingles are in fair condition, but poor and aged appearance. Signs of drying and curling.
